Park Asset Management Plan

Missoula Parks and Recreation

January, 2014

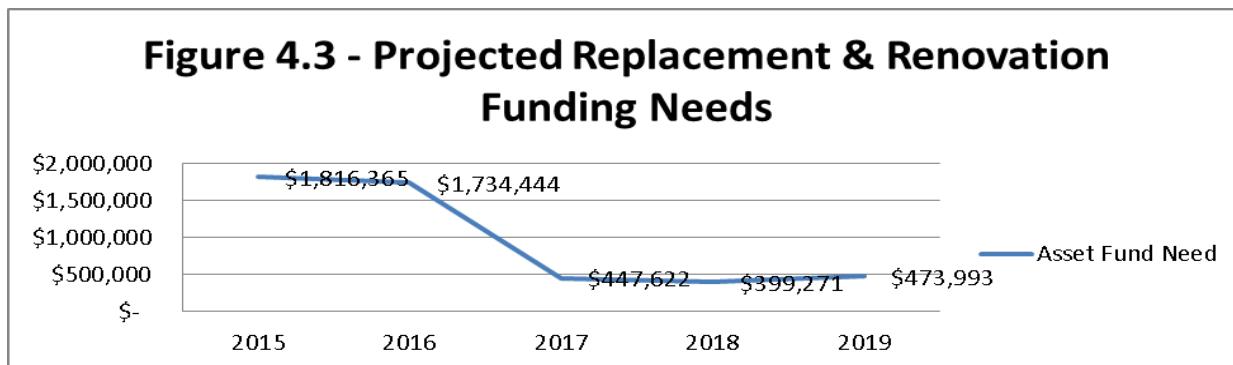
The figure below shows projected immediate and forecast replacement/renovation funding needs for the next five years. This analysis recommends funding for the most pressing immediate needs be realized in City fiscal years 2015 and 2016. This may not be feasible so costs may need to be spread out over a larger number of budget cycles. The exact timing of replacements and renovations will be determined by the Mayor and City Council given overall revenues, funding needs, sources, and city-wide priorities.

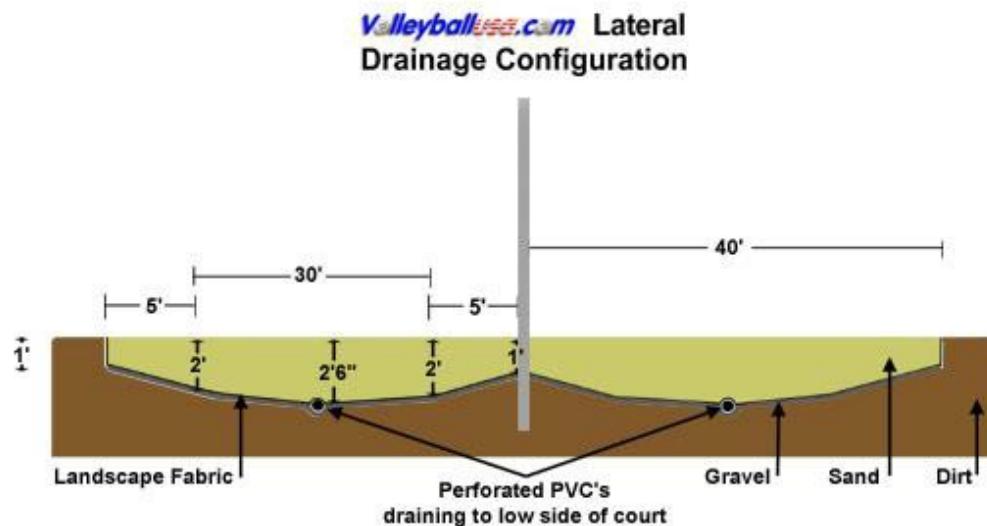
Outdoor volleyball courts are present at seven parks in the City of Missoula. Construction consists of a few basic elements to ensure longevity of the court. First, a layer of gravel approximately 6" deep should be placed on top of the existing surface with low point on each side of the net to allow proper drainage. Next, a layer of landscape fabric should be placed on top of the gravel to prevent the sand from filling the voids between the gravel, and to prevent vegetation from growing up through the sand playing surface. A layer of sand with depths varying between 1-3 feet deep should be the last material added to make up the playing surface. See detailed diagram below.

An unmaintained playing surface can lead to an unpleasant playing surface for users. Low spots in the sand can lead to injuries due to abrasions that result from diving for a ball. Sand that is not routinely raked can collect garbage, which can be unsightly and even dangerous.

A volleyball court in good condition will consist of a smooth playing surface free from irregularities, debris, vegetation, and ponding water. The sand will be evenly distributed, the net will be taut, and the poles will be sturdy in place. The border shall be in place, and prevent vegetation from growing into the sand, and also prevent the sand from leaving the playing area.

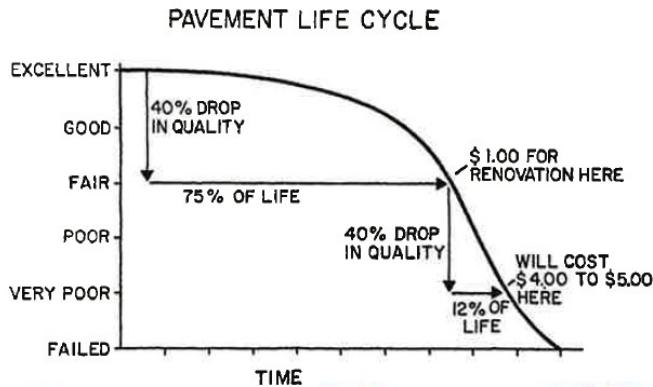
At some point the decision needs to be made if continually reactive maintenance is justified or if major renovation or complete reconstruction of the lot is a more economical decision. Typically, asphalt pavements deteriorate slowly following construction for a period of time. At some point, the rate of deterioration increases, resulting in significantly increased maintenance costs. Many organizations apply the Critical PCI (Pavement Condition Index) Method in order to determine the optimal point during an asphalt pavement life cycle for major renovation and to delay the need for complete replacement. The basic premise behind this method is that the cost of a major repair to an asphalt surface near the end of the pavement life span will exceed 4 times that of a repair made prior to the increase of rate of deterioration.

While implementation of the Critical PCI Method is outside the scope of this discussion, the concepts remain valid. Significant economic savings can be gained by the completion of preventative maintenance as described above, and when increased deterioration rates can be identified during periodic inspections, repair costs can be minimized by initiating major repairs prior to further pavement degradation.
