Levee Management

Tracy Campbell, Regulatory Compliance Manager
(406) 552-6364
campbellTL@ci.missoula.mt.us

Introduction

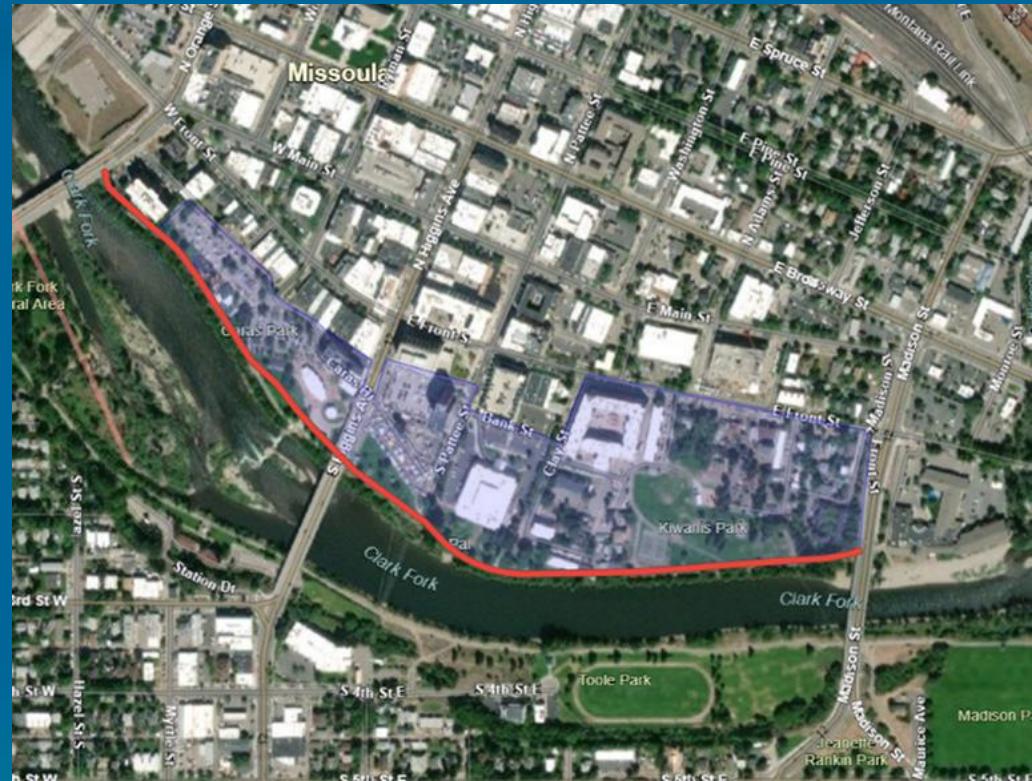
Clark Fork Area III

Majority of recommendations include repairing cracking and spalling on the floodwall and maintaining vegetation.

Estimate to remove unacceptable vegetation along the flood wall: \$45,000

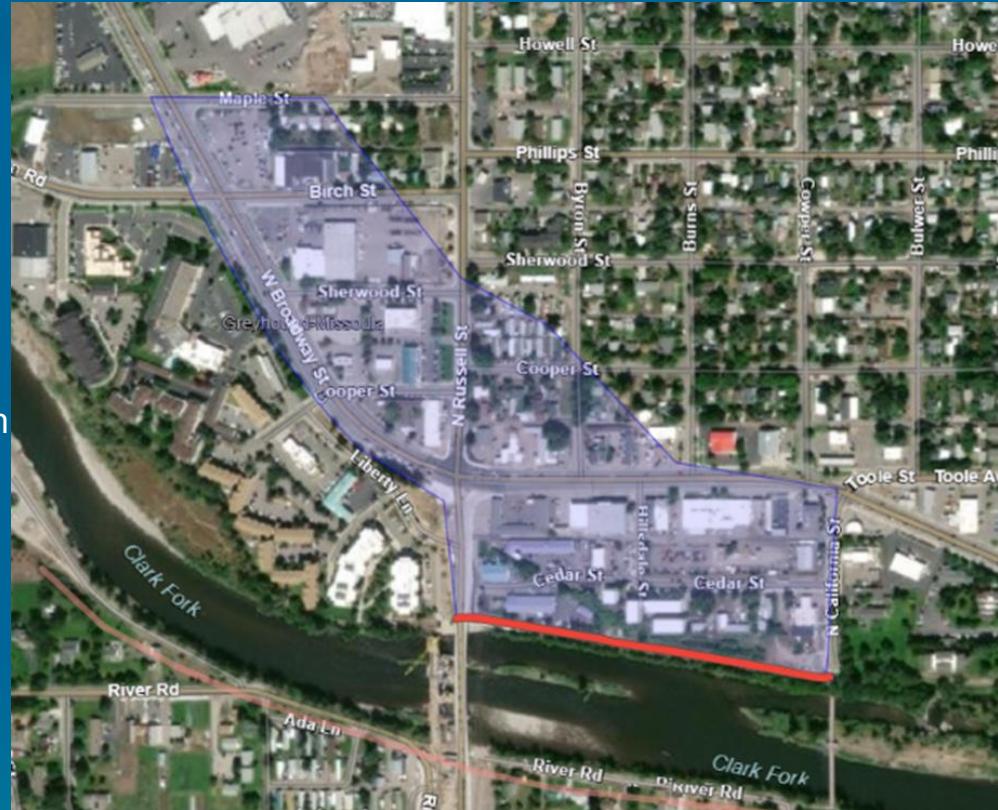
Clark Fork Area V

Annual inspection by USACE and City
USACE Rating: Minimally Acceptable
Majority of the recommendations
include maintenance of vegetation and
riprap.

February 2020
Unacceptable vegetation removed from riverward side of levee
\$29,000

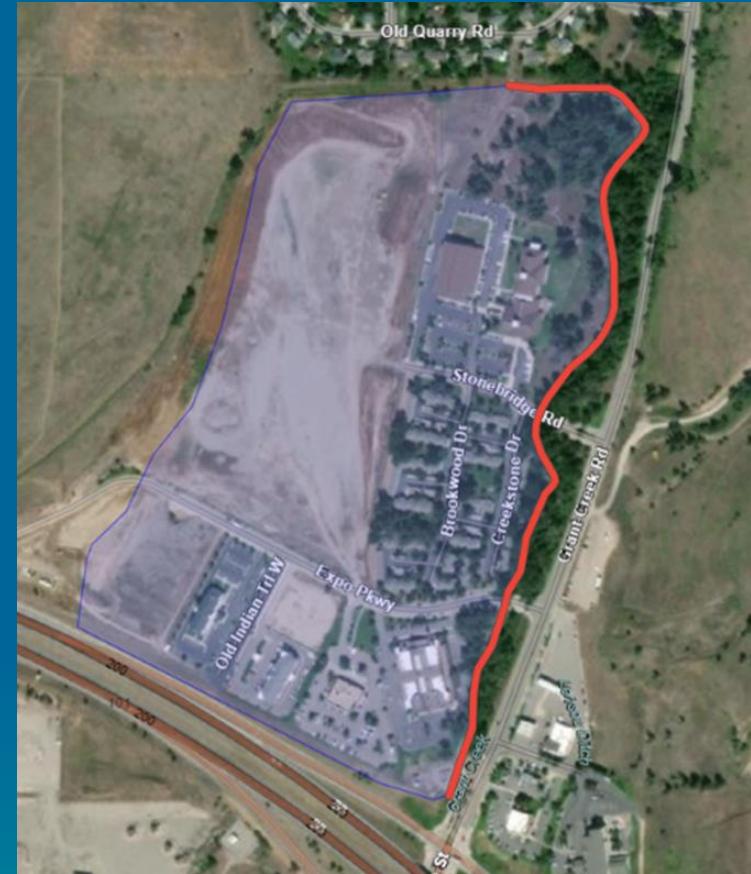
Grant Creek

Majority of recommendations include removing excess vegetation and repairing locations of scour and erosion.

Estimate to removed unacceptable vegetation:

\$700,000

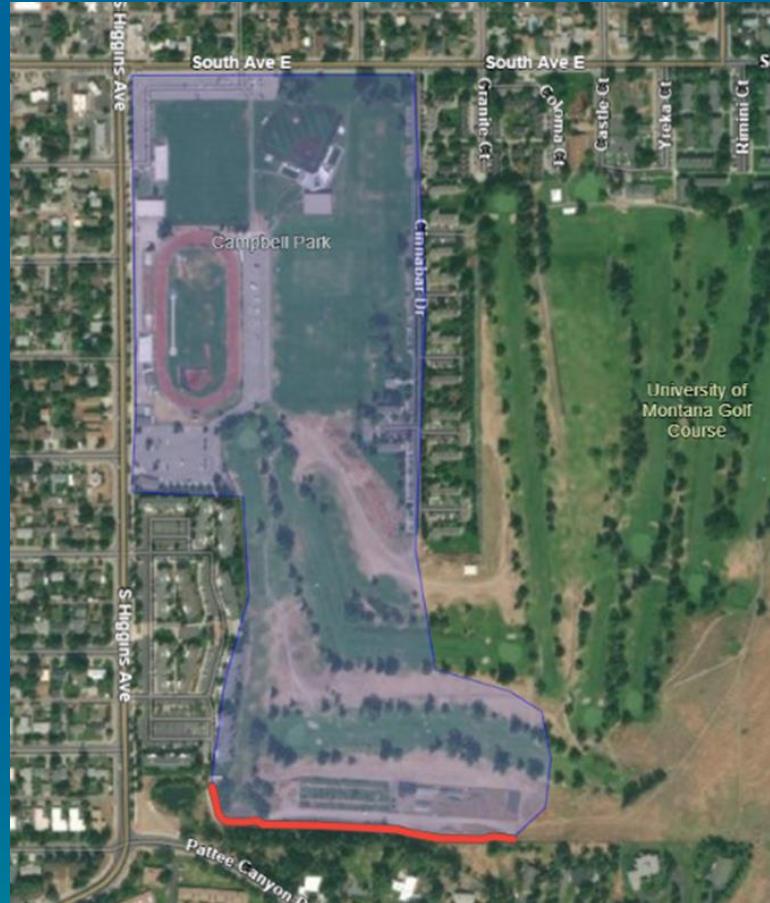
Pattee Creek

Annual inspection by City
Periodic inspection by USACE every 5 years
USACE Rating: Acceptable
Majority of recommendations include maintaining
vegetation to comply with USACE standards and
monitoring/controlling burrowing animal activity.

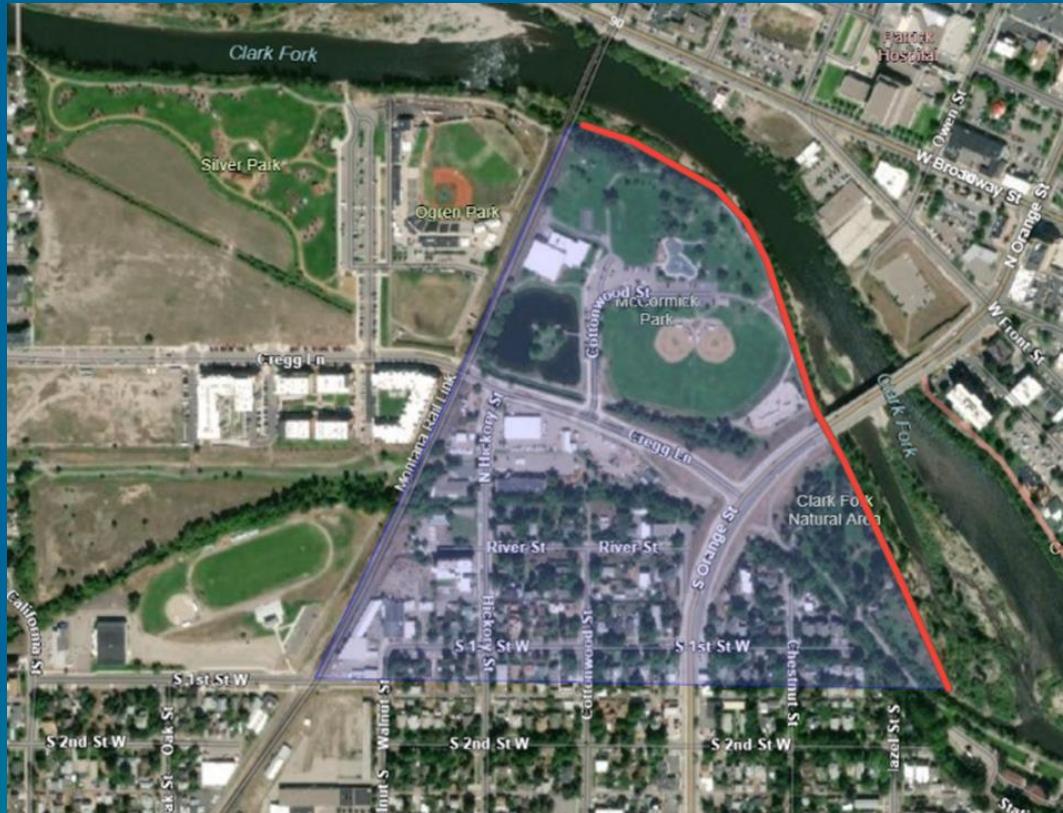
McCormick Park

- Built: repaired 1964
(unclear when it was originally constructed)
 - Non-accredited since 1990
 - Locally funded,
non-federal levee
(likely, but not confirmed)
 - Length:
0.49 miles of embankment
 - Population: 275
 - Structures protected: 107
 - Estimated property value:
\$80.8 million

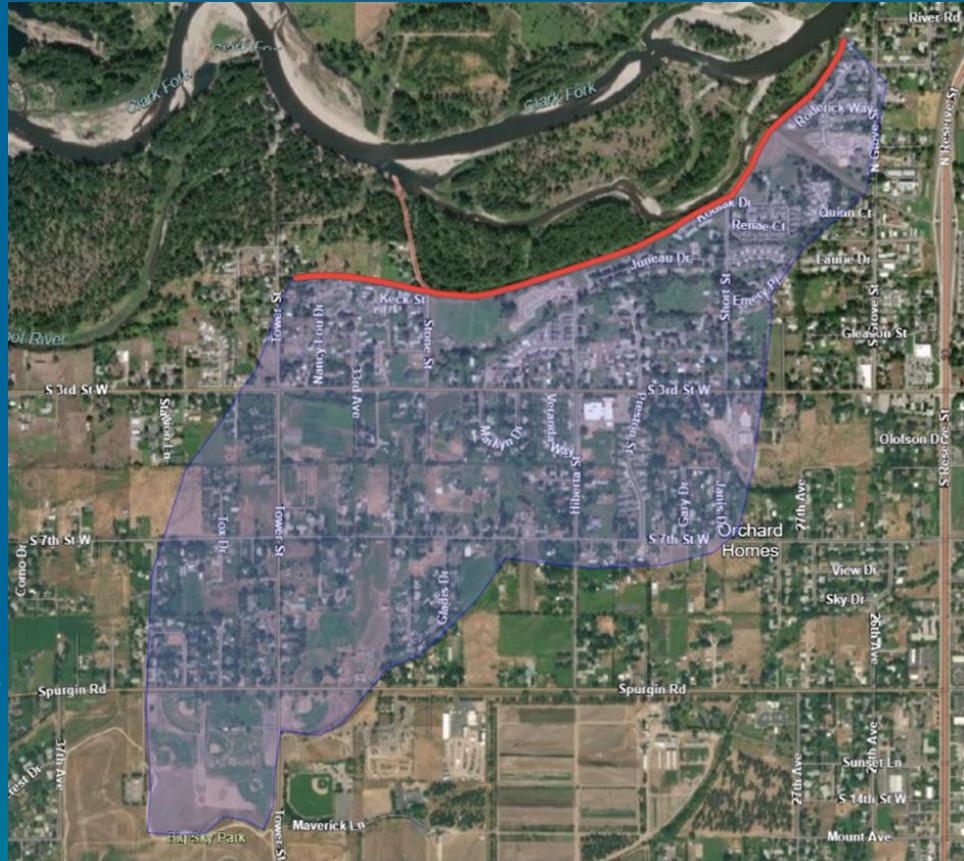
Orchard Homes

Annual inspection by County
Periodic inspection by USACE every 5 years
USACE Rating: Minimally Acceptable
Majority of recommendations include
removing excess vegetation and
repairing locations of scour and erosion.

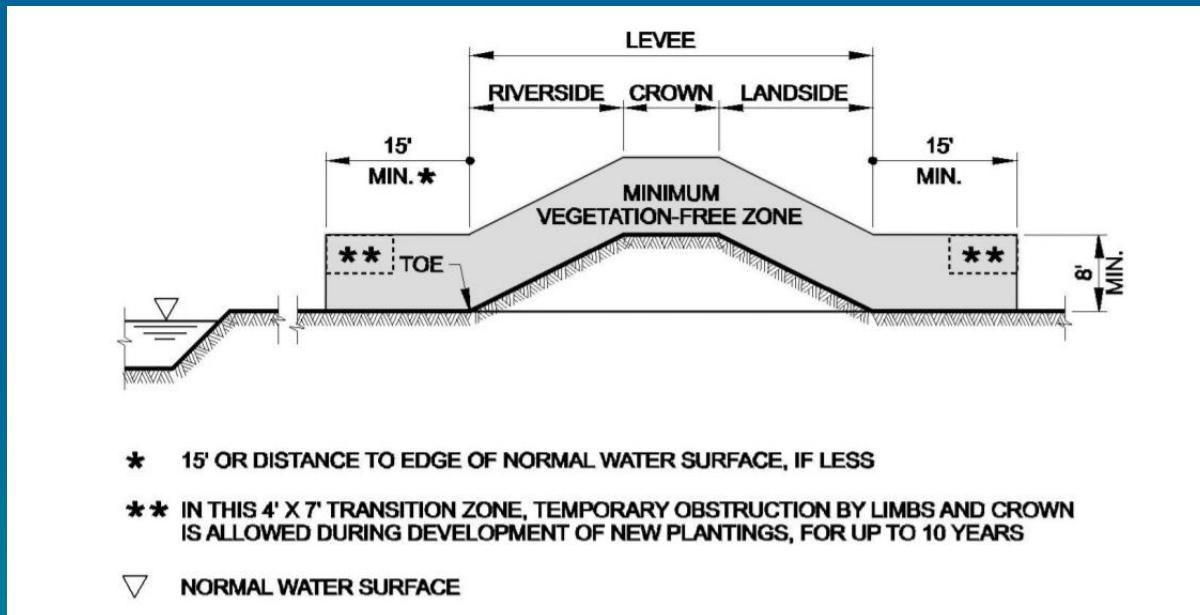
Vegetation Maintenance

Remove vegetation not in compliance with USACE vegetation standards. The crown, slopes, and 15 feet from the toe of the levee or floodwall should be clear of vegetation as the regulation originally stated in Engineering Technical Letter (ETL) 1110-2-583 (expired) and Engineering Pamphlet (EP) 1110-2-18.

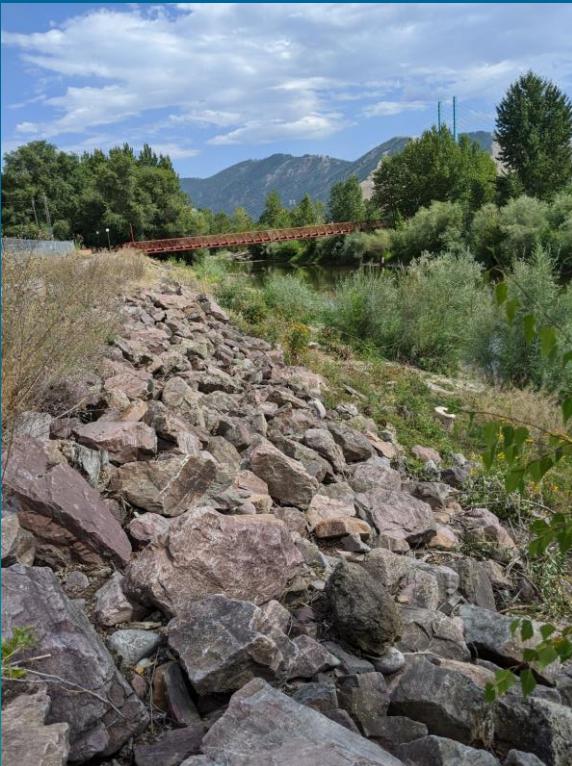
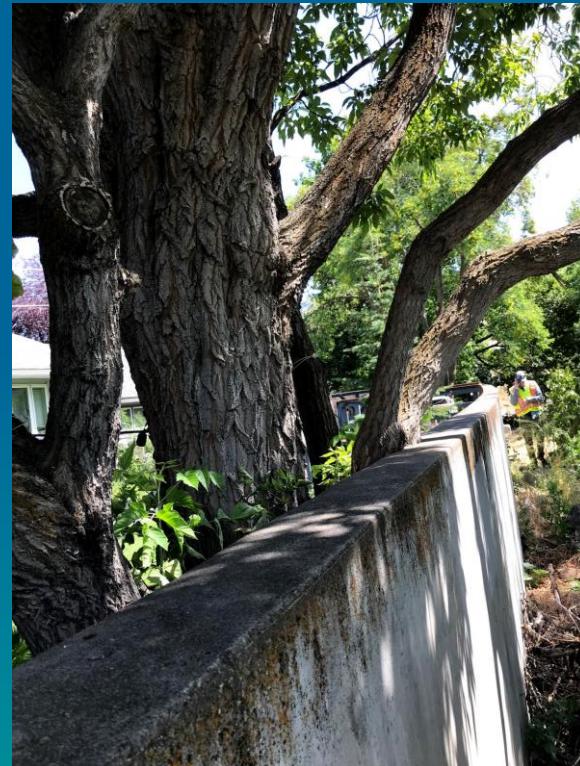
Vegetation Maintenance

Remove vegetation not in compliance with USACE vegetation standards. The crown, slopes, and 15 feet from the toe of the levee or floodwall should be clear of vegetation as the regulation originally stated in Engineering Technical Letter (ETL) 1110-2-583 (expired) and Engineering Pamphlet (EP) 1110-2-18.

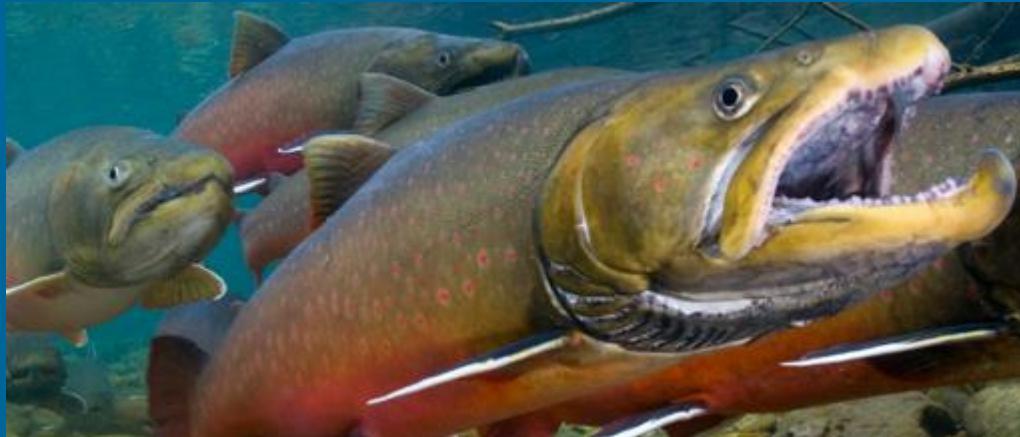
Vegetation Maintenance

USACE recognizes that the protections provided to threatened and endangered species, like bull trout, may supersede their vegetation guidelines.

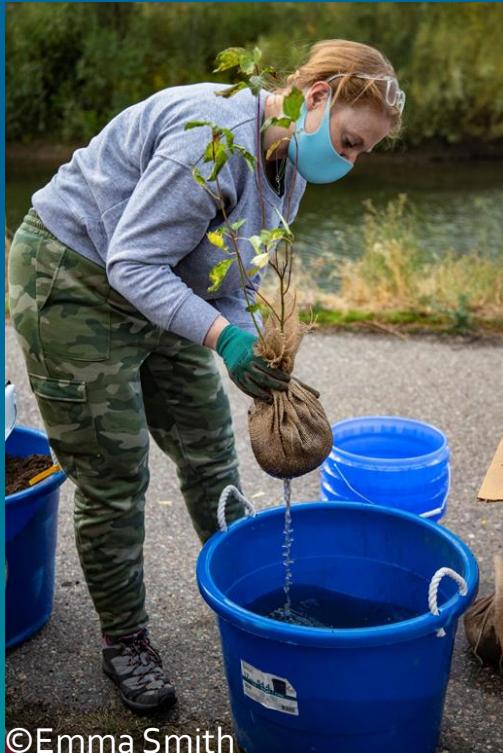
“Growth of sod and willows or brush on the levee slopes may be encouraged as it will increase bank stabilization and decrease erosion from flood flows. The growth of trees on the levee shall be prevented.” *Clark Fork Area III and V Levees Operation and Maintenance Manual 1968, written by the U.S. Army Corps of Engineers*

Remove all non-native vegetation and cottonwoods, transition levee slopes to native shrub cover, where diameter at breast height < 4 inches.

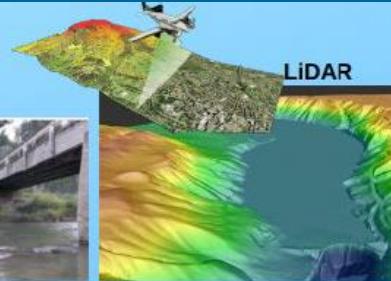
Step 1 - Survey: The type of the survey depends on the size of the study area and type of study.

Step 1 - Survey: measurements are made of the topography around the river, along with any culverts, bridges, and road crossings. LiDAR uses an airplane to collect ground elevation over a large area, and ground survey supplements the airborne data.
