**CULTURAL RESOURCE SURVEY:  
ASPIRE SUBDIVISION/DENOVA HOMES,  
MISSOULA COUNTY, MONTANA**

A single site, **24MO1924** (885 Speedway Dr.), was located and recorded during the survey and is recommended as *Not Eligible*. According to 36 CFR 800.5 an adverse effect is found when an undertaking may alter, directly or indirectly, any of the characteristics of a historic property that qualifies the property for inclusion in the National Register in a manner that would diminish the integrity of the property (MT SHPO, 2000). Due to the site being listed as *Not Eligible* for inclusion in the National Register, it is recommended that no further archaeological work be performed and that the project proceed as planned. This report summarizes the findings of the archeological survey conducted by Western Cultural on December 14, 2023.

24MO1924

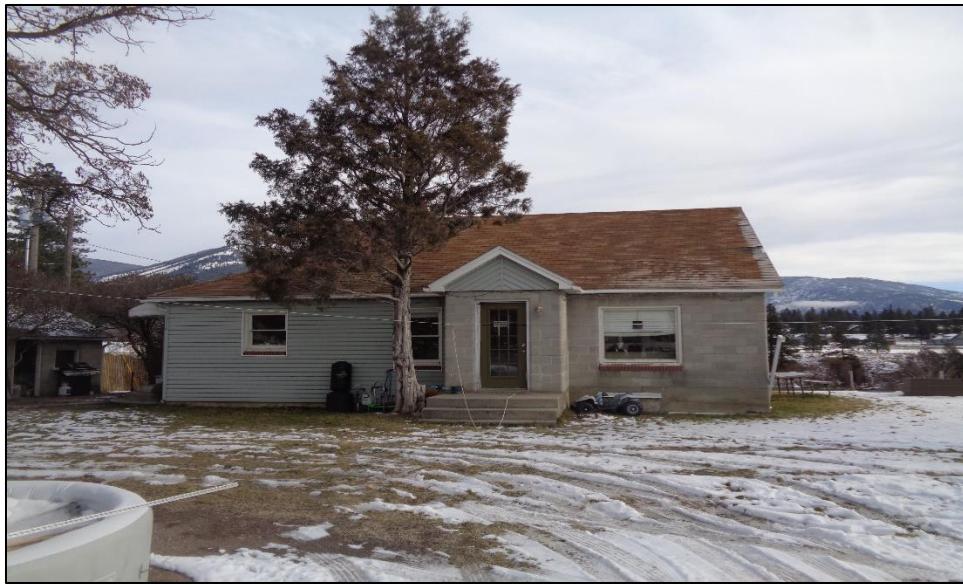
Figure 2. F-1, residence, view to the east.

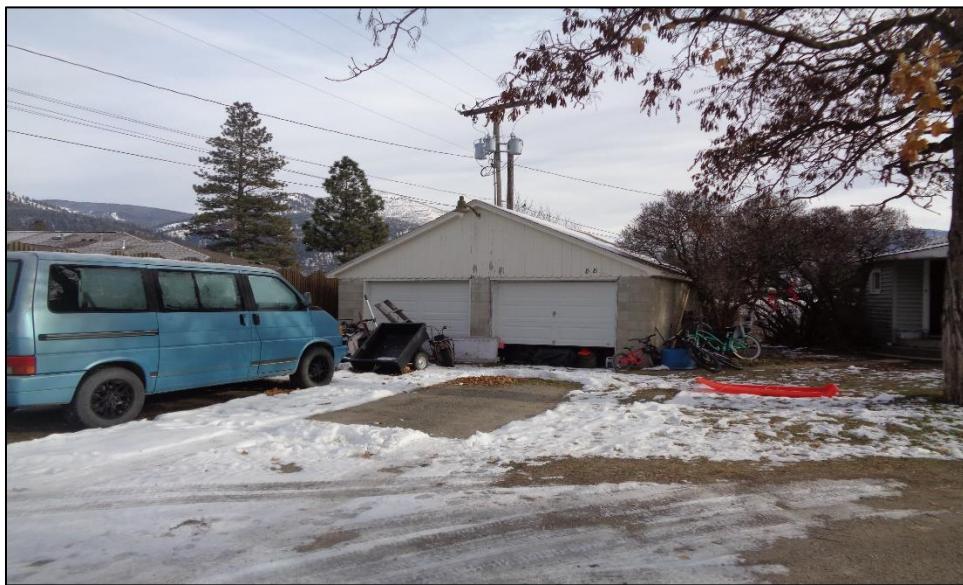
Figure 3. F-2, detached garage, view to the east.

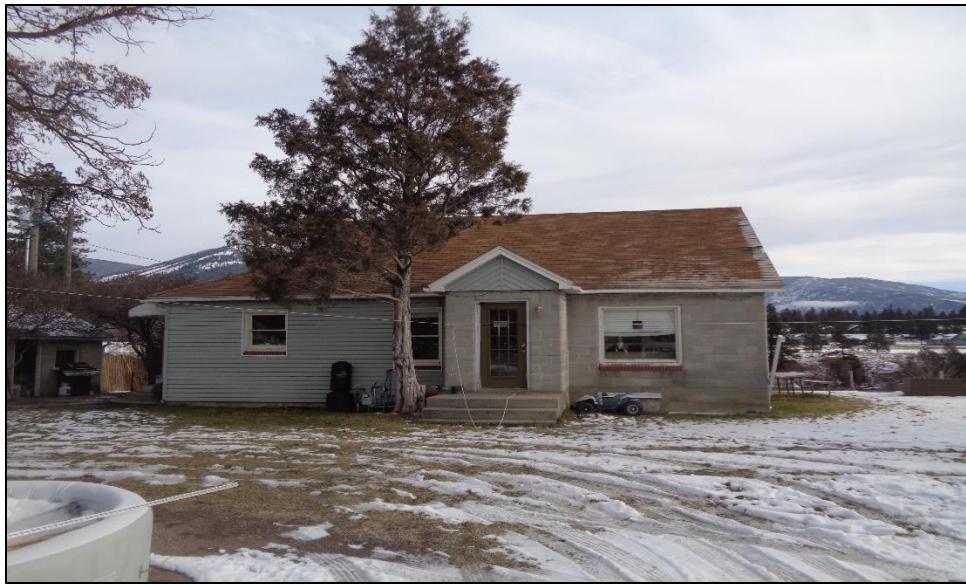
The west elevation features five openings. The first opening is a two-pane horizontal sliding window that measures 2 ft x 3 ft with white trim and a brick lip at the bottom. The second opening is a window nearly identical to the first but measures 2 ft x 4 ft. The main entrance door is placed in an enclosed porch. The door is of green wood with a full length 3 x 5 pane window set into it. Next to the door is a 4 ft x 4 ft single pane window with similar trim and brick as the others. On the north side of the elevation is another enclosed porch area with a door leading to the interior.

Figure 10. Building 1, residence, west elevation, view to the east.

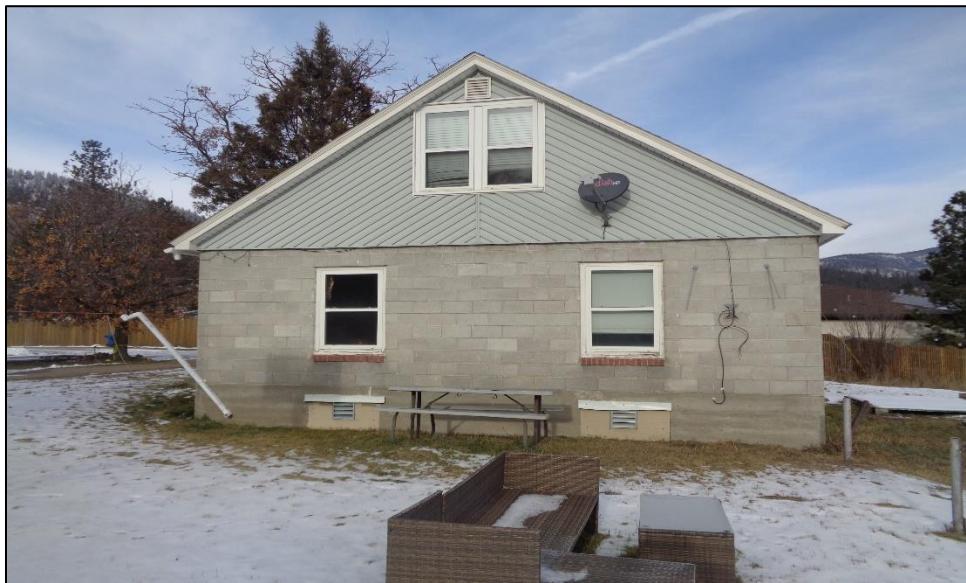
The south elevation features three openings. The first is a single pane 5 ft x 5 ft window set just below the gable in the roof. On the first floor are two identical 2.5 ft x 4.5 ft two pane horizontal sliding windows. Below the first-floor windows are two vents. The gable features diagonal lap board siding while the first floor is concrete blocks.

Figure 11. Building 1, residence, south elevations, view to the north.

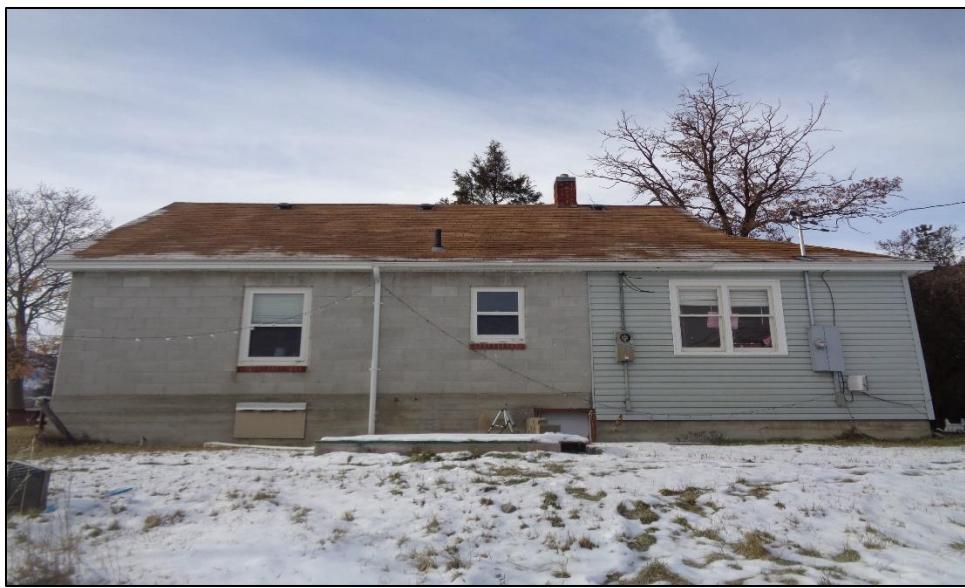
The east elevation features four openings. On the north side is a 6 ft x 6 ft two pane horizontal sliding window. at the center of the elevation is 2 ft x 3.5 ft horizontal sliding window with similar white trim and brick as the south elevation. At the south end is 2 ft x 4.5 ft double pane horizontal sliding window with white trim. At the center of the elevation is a set of concrete stairs leading down to the basement entrance door. There is an air vent at the south end of the elevation. An 8 ft x 8 ft wooden platform is constructed just off the elevation.

Figure 12. Building 1, residence, east elevation, view to the west.

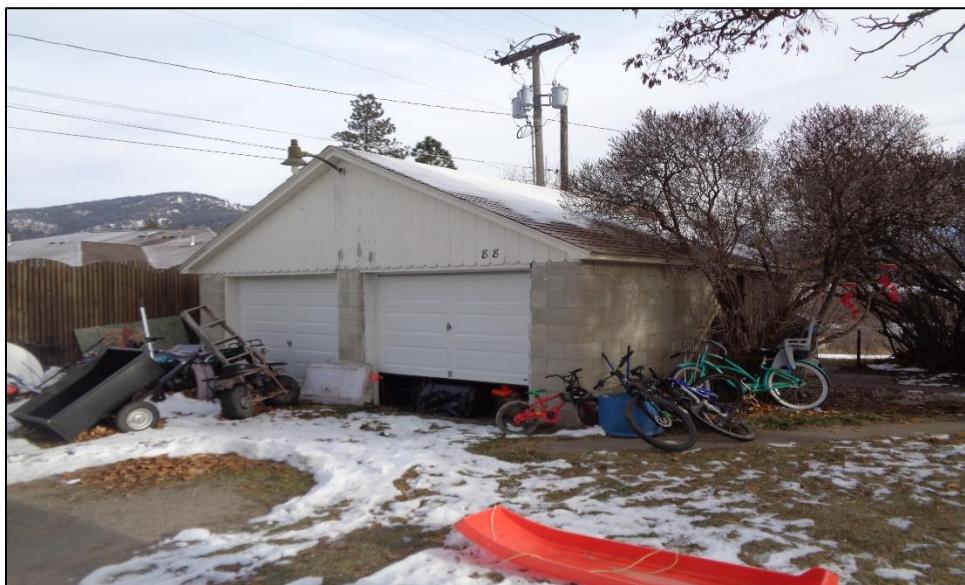
The detached garage (F-2) is constructed of concrete blocks, with a cement foundation, and a gabled brown asphalt shingle roof. The structure measures 15 ft n-s by 25 ft e-w. In the gable

portions of the structure vertical whitewashed fence boards have been placed. The west elevation features two openings, two identical rolling garage doors that measure 10 ft x 8 ft. The south elevation features two openings, one window and a door. The window is single pane and measures 2 ft x 2 ft. The east elevation features one single pane window measuring 2 ft x 2 ft. The north elevation features no openings, and a wooden fence blocks any view of the elevation.

Figure 13. Building 2, detached garage, south and west elevations, view to the northeast.

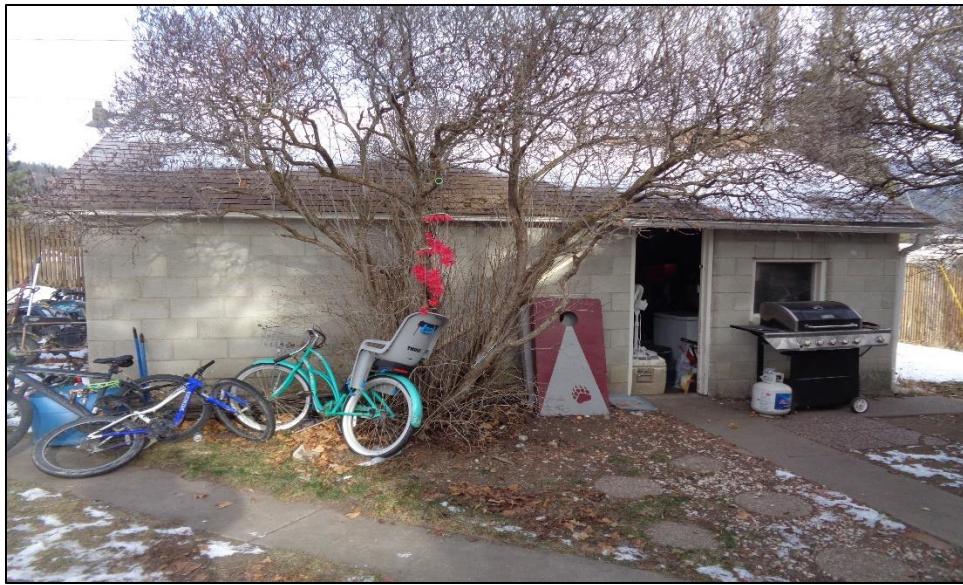
Figure 14. Building 2, detached garage, east elevation, view to the west.

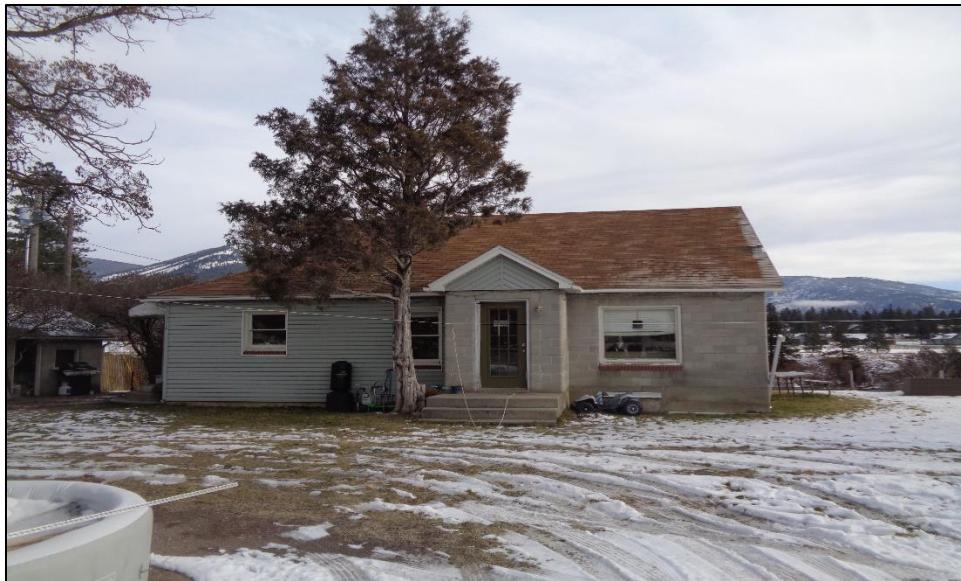
THE WEST ELEVATION THE FIRST IS A TWO PANE HORIZONTAL SLIDING WINDOW THAT MEASURES 2 FT X 3 FT WITH WHITE TRIM AND A BRICK LIP AT THE BOTTOM. THE SECOND OPENING IS A WINDOW NEARLY IDENTICAL TO THE FIRST BUT MEASURES 2 FT X 4 FT. THE MAIN ENTRANCE DOOR IS PLACED IN AN ENCLOSED PORCH. THE DOOR IS OF GREEN WOOD WITH A FULL LENGTH 3 X 5 PANE WINDOW SET INTO IT. NEXT TO THE DOOR IS A 4 FT X 4 FT SINGLE PANE WINDOW WITH SIMILAR TRIM AND BRICK AS THE OTHERS. ON THE NORTH SIDE OF THE ELEVATION IS ANOTHER ENCLOSED PORCH AREA WITH A DOOR LEADING TO THE INTERIOR.

Figure 1. Building 1, residence, west elevation, view to the east.

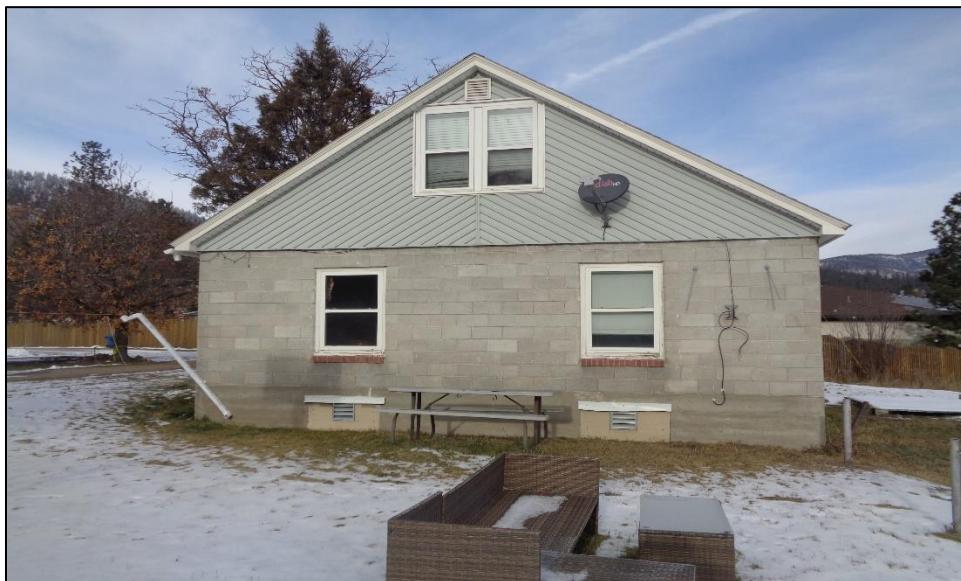
THE SOUTH ELEVATION FEATURES THREE OPENINGS. THE FIRST IS A SINGLE PANE 5 FT X 5 FT WINDOW SET JUST BELOW THE GABLE IN THE ROOF. ON THE FIRST FLOOR ARE TWO IDENTICAL 2.5 X 4.5 FT TWO PANE HORIZONTAL SLIDING WINDOWS. BELOW THE FIRST FLOOR WINDOWS ARE TWO VENTS. THE GABLE HAS FEATURES DIAGONAL LAP BOARD SIDING WHILE THE FIRST FLOOR IS CONCRETE BLOCKS.

Figure 2. Building 1, residence, south elevations, view to the north.

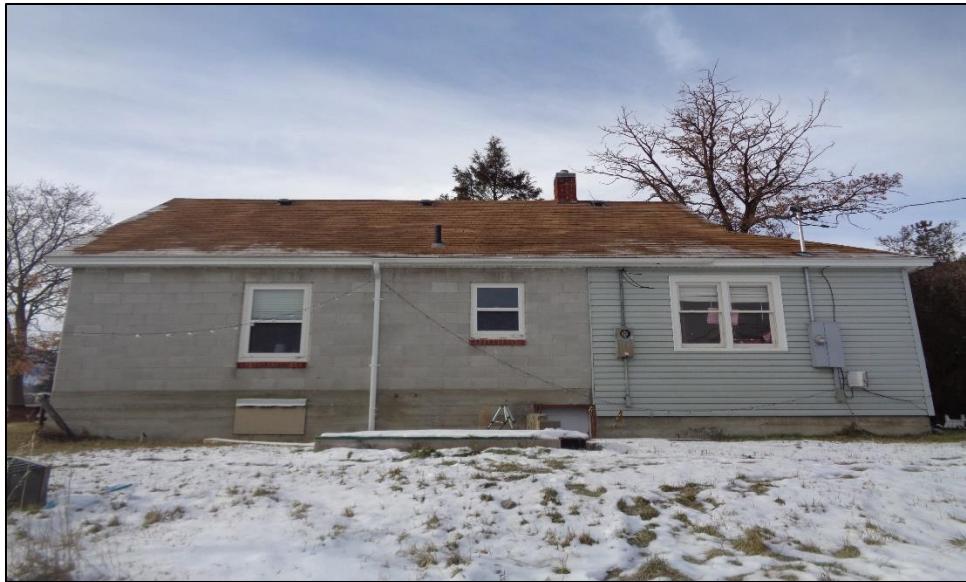
THE EAST ELEVATION FEATURES FOUR OPENINGS. ON THE NORTH SIDE IS A 6 FT X 6 FT TWO PANE HORIZONTAL SLIDING WINDOW. AT THE CENTER OF THE ELEVATION IS 2 FT X 3.5 FT HORIZONTAL SLIDING WINDOW WITH SIMILAR WHITE TRIM AND BRICK AS THE SOUTH ELEVATION. AT THE SOUTH END IS 2 FT X 4.5 FT DOUBLE PANE HORIZONTAL SLIDING WINDOW WITH WHITE TRIM. AT THE CENTER OF THE ELEVATION IS A SET OF CONCRETE STAIRS LEADING DOWN TO THE BASEMENT ENTRANCE DOOR. THERE IS AN AIR VENT AT THE SOUTH END OF THE ELEVATION. AN 8 FT X 8 FT WOODEN PLATFORM IS CONSTRUCTED JUST OFF THE ELEVATION.

Figure 3. Building 1, residence, east elevation, view to the west.

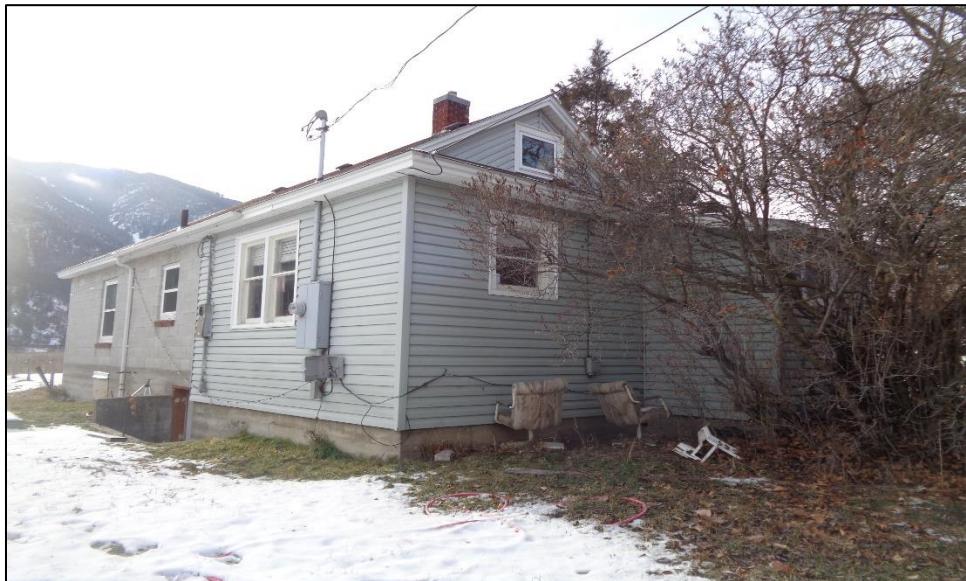
THE NORTH ELEVATION FEATURES FOUR OPENINGS. ON THE EAST SIDE IS A 2 FT X 2.5 FT DOUBLE PANE HORIZONTAL SLIDING WINDOW WITH WHITE TRIM. AT THE CENTER IS A 2 FT X 1.5 FT SINGLE PANE WHITE TRIMMED WINDOW. THE WEST SIDE OF THE ELEVATION FEATURES A 2.5 FT X 2.5 FT SINGLE PANE WHITE TRIMMED WINDOW. UNDER THE GABLE OF THE ROOF IS A 2 FT X 2 FT SINGLE PANE WHITE TRIMMED WINDOW.

Figure 4. Building 1, residence, north and east elevations, view to the southwest.

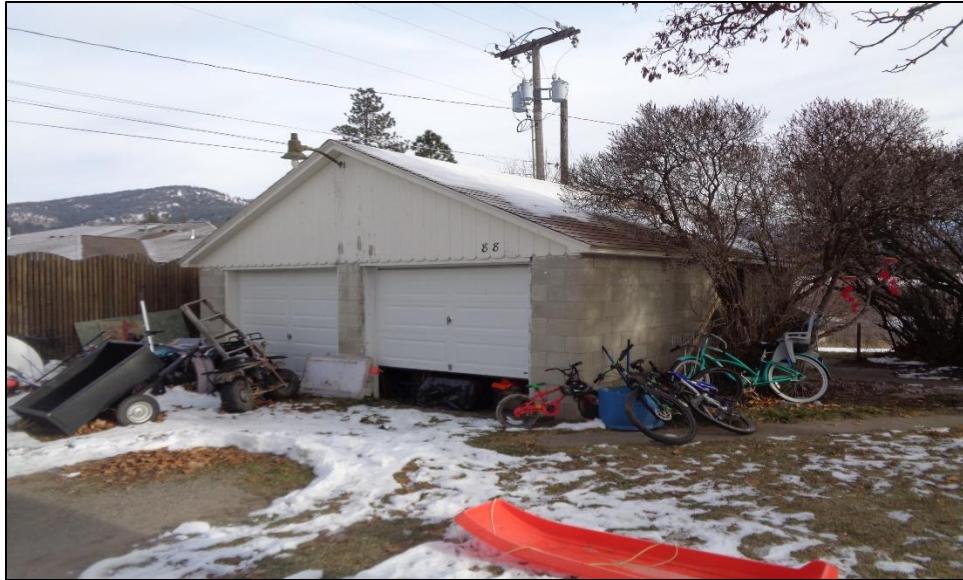
THE DETACHED GARAGE (F-2) IS CONSTRUCTED OF CONCRETE BLOCKS, WITH A CEMENT FOUNDATION, AND A GABLED BROWN ASPHALT SHINGLE ROOF. THE STRUCTURE MEASURES 15 FT N-S BY 25 FT E-W. IN THE GABLE PORTIONS OF THE STRUCTURE VERTICAL WHITE WASHED FENCE BOARDS HAVE BEEN PLACED. THE WEST ELEVATION FEATURES TWO OPENINGS, TWO IDENTICAL ROLLING GARAGE DOORS THAT MEASURE 10 FT X 8 FT. THE SOUTH ELEVATION FEATURES TWO OPENINGS, ONE WINDOW AND A DOOR. THE WINDOW IS SINGLE PANE AND MEASURES 2 FT X 2 FT. THE EAST ELEVATION FEATURES ONE SINGLE PANE WINDOW MEASURING 2 FT X 2 FT. THE NORTH ELEVATION FEATURES NO OPENINGS AND A WOODEN FENCE BLOCKS ANY VIEW OF THE ELEVATION.

Figure 5. Building 2, detached garage, south and west elevations, view to the northeast.

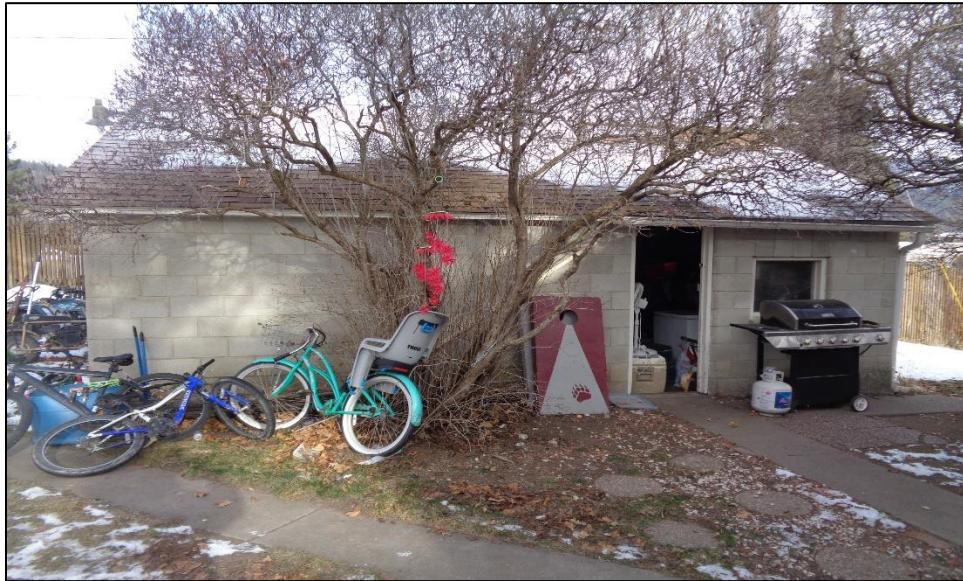
Figure 6. Building 2, detached garage, east elevation, view to the west.

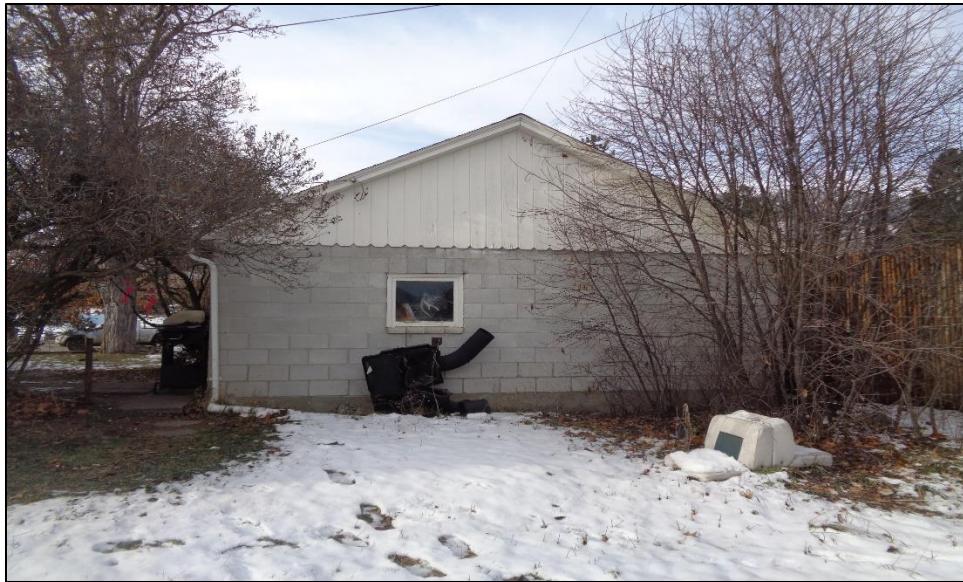
Figure 7. Building 2, detached garage, east elevation, view to the west.
