TECHNICAL MEMORANDUM

Subject: *Hillview Subdivision Aquatic Resources Delineation Technical Memorandum*

EXHIBIT A: HILLVIEW SUBDIVISION AQUATIC RESOURCES DELINEATION MAP

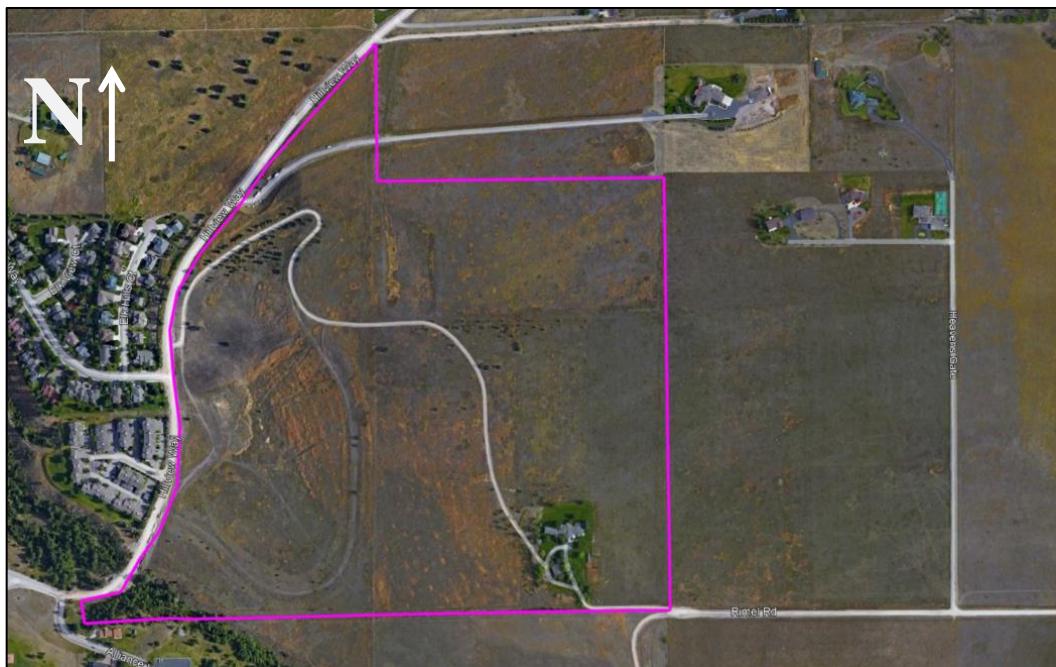
Figure 1. Proposed Hillview Subdivision delineation investigation area (pink polygon), Missoula, Montana.

An aquatic resources delineation was conducted within the proposed Hillview Subdivision property located in Missoula, Montana in Missoula County (SESE Section 6 and SWSW Section 5, Township 12 North, Range 19 West: **Figures 1 and 1a**; 46.821427, -114.022690). The proposed project site is located within agricultural grassland and includes one home.

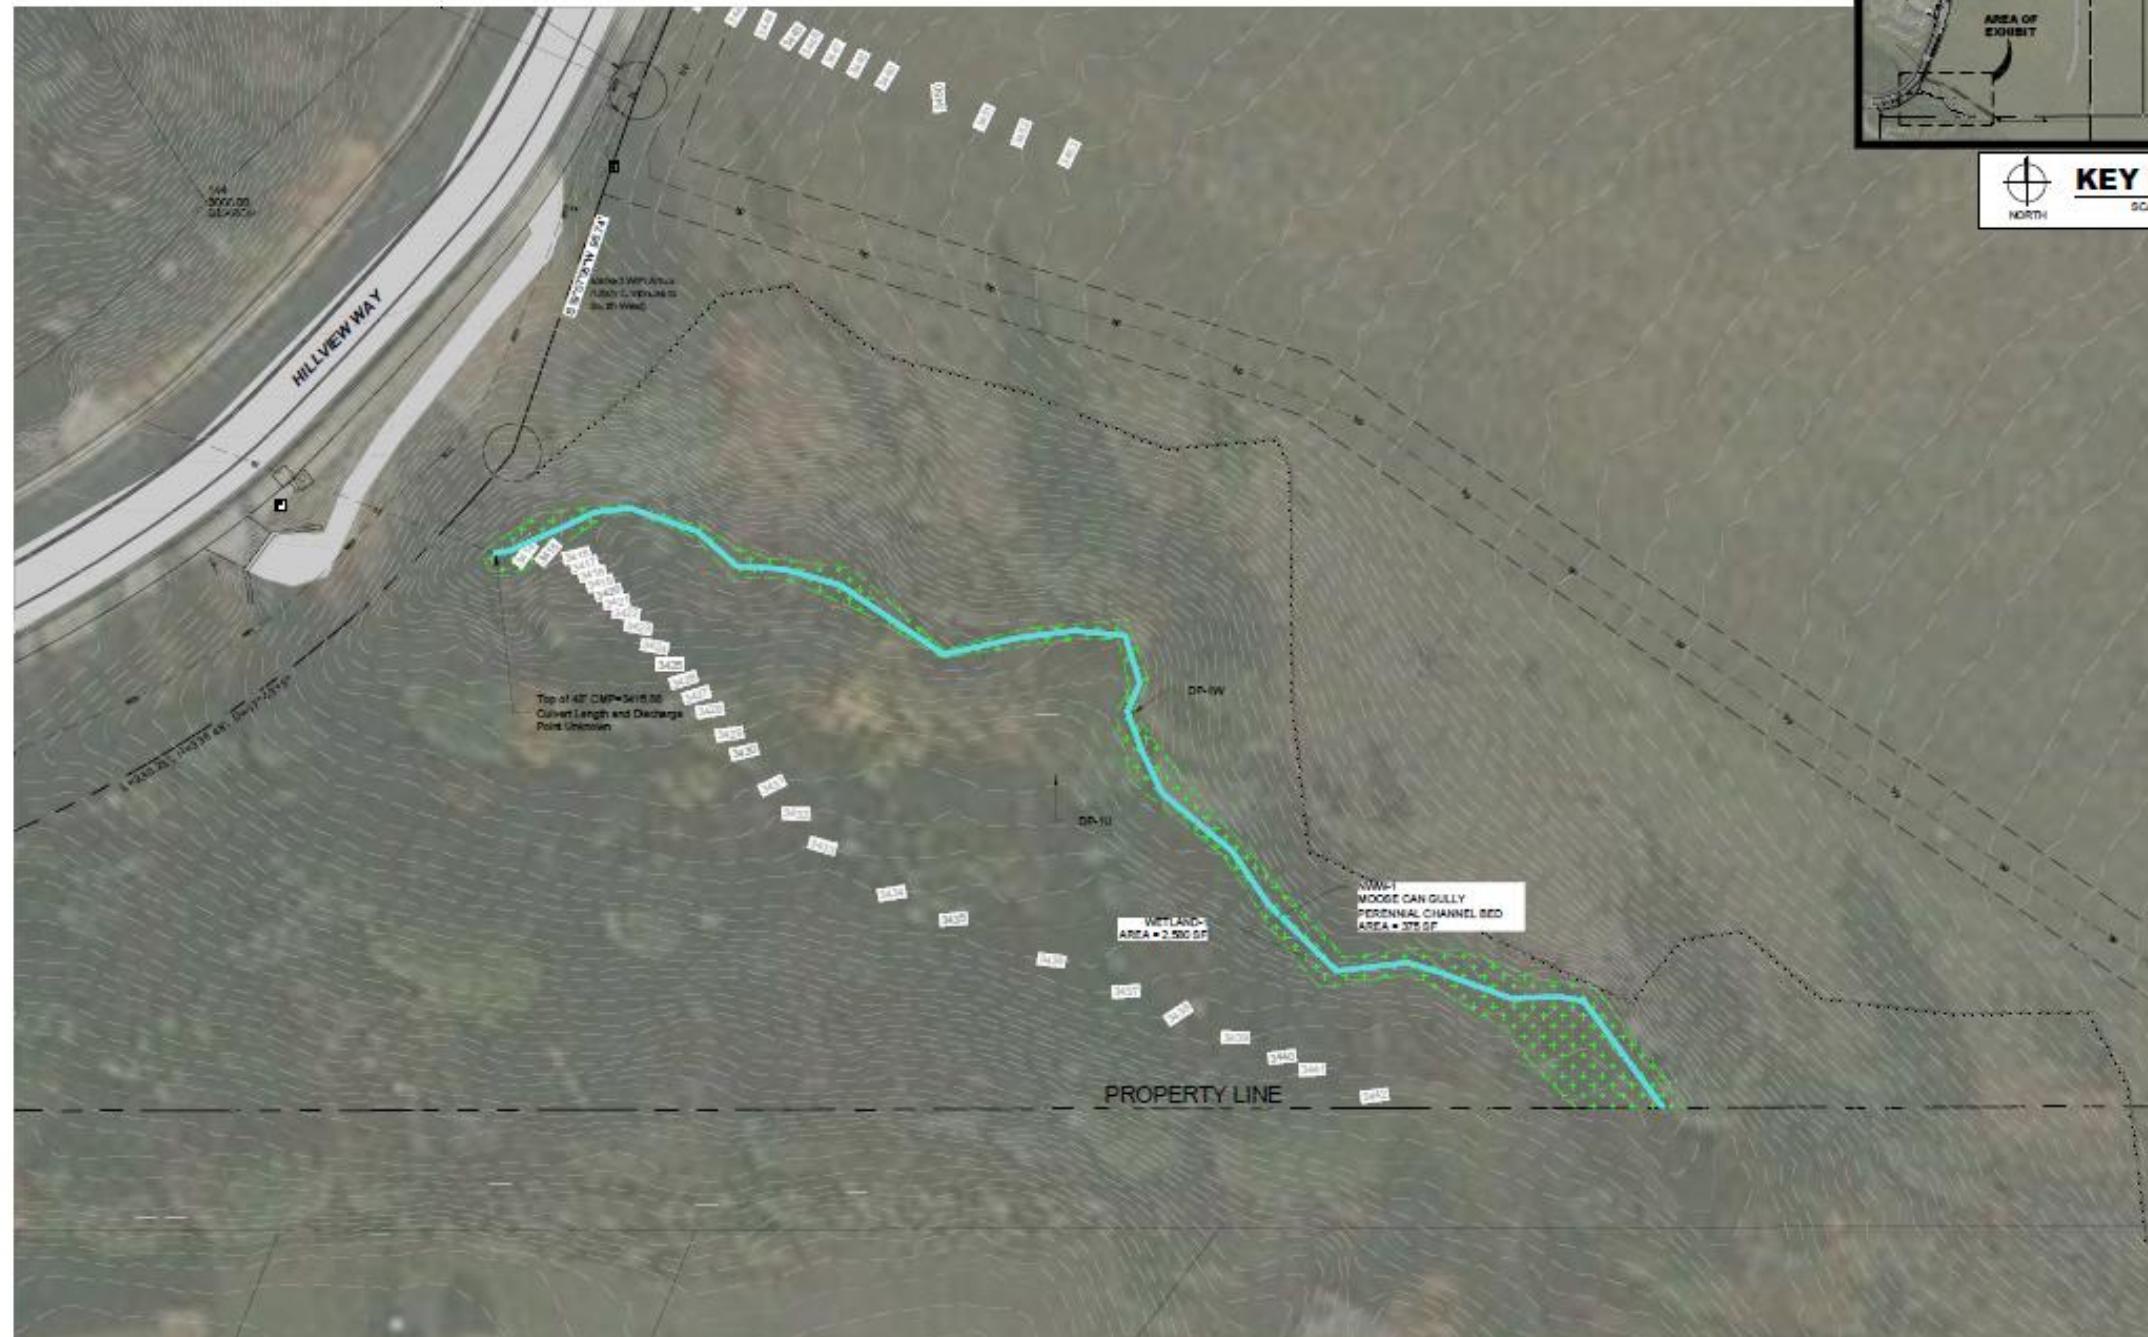
WETLAND EXHIBIT
EX-A

DELINeATION CONDUCTED BY
TERRAQUATIC, LLC ON 9/26/2021

1 AQUATIC RESOURCE EXHIBIT

An aquatic resources delineation was conducted within the proposed Hillview Subdivision project site on September 28, 2021 (**Ex- A, Appendix A**). One aquatic feature was identified in the southwest corner of the property. The feature includes an unnamed perennial stream channel (NWW-1: 375 sqft) within Moose Can Gully and a narrow wetland fringe (WL-1: 2,580 sqft) along both sides. The stream channel is narrow and averages 1 to 1.5 feet wide. A feature identified as a pond in the center of the property by Montana Natural Heritage Program (2021) does not exist.

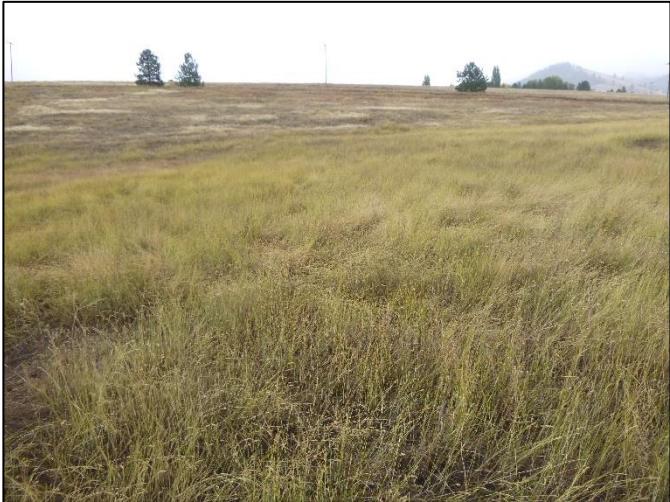
Photo 1. General proposed subdivision vegetation community; view northeast.

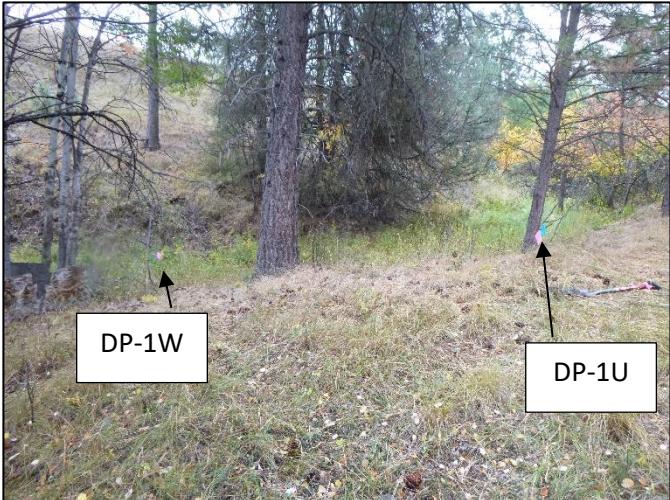
Photo 3. Wetland-1 (green vegetation in gully center) along perennial channel bed (NWW-1) within Moose Can Gully; DP-1W (wetland data point: left blue/pink flags) and DP-1U (upland); view southwest.

Moose Can Gully is located within a robust riparian swale with steep slopes along both sides. The vegetation community along the slopes is comprised of quaking aspen (*Populus tremuloides*), ponderosa pine (*Pinus ponderosa*), choke cherry (*Prunus virginiana*), snowberry (*Symporicarpos* sp.), and nonnative grass species (orchard grass: *Dactylis glomerata*, timothy: *Phleum pratense*, and smooth brome: *Bromus inermis*). Dominant wetland species along the channel include nonnative spreading bent (*Agrostis stolonifera*), sedge species (*Carex* sp.) and manna grass along the perennial stream channel. Soils within the wetland fringe and upland slope areas are very dark grayish brown (10YR 3/2) and very rocky at a depth of 12 inches below ground surface (BGS; unable to excavate deeper). Given true hydric indicators could not be observed within the wetland fringe because of the large broken rock interface at 12 inches BGS, soils were classified as hydric based on proximity to the perennial stream, potential for saturation, geomorphic position, and dominance of hydrophytic species. The Moose Can Gully aquatic resource qualifies as a riverine, perennial, rock bottom, palustrine, emergent channel bed wetland system (Cowardin 1979).

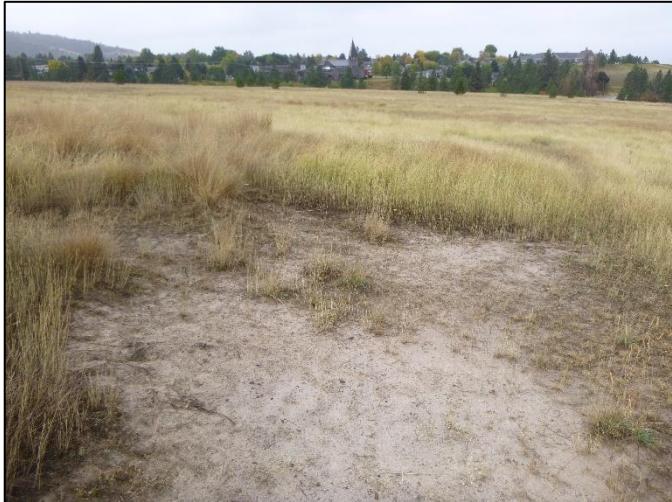
Photo 2. Bare spot in west center of property where wildlife likely congregate.

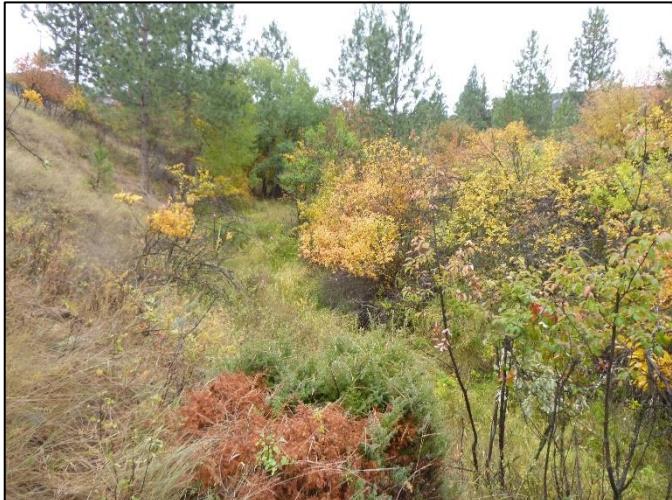
Photo 4. General photo of Moose Can Gully vegetation within wetland fringe and upland slope; view west.

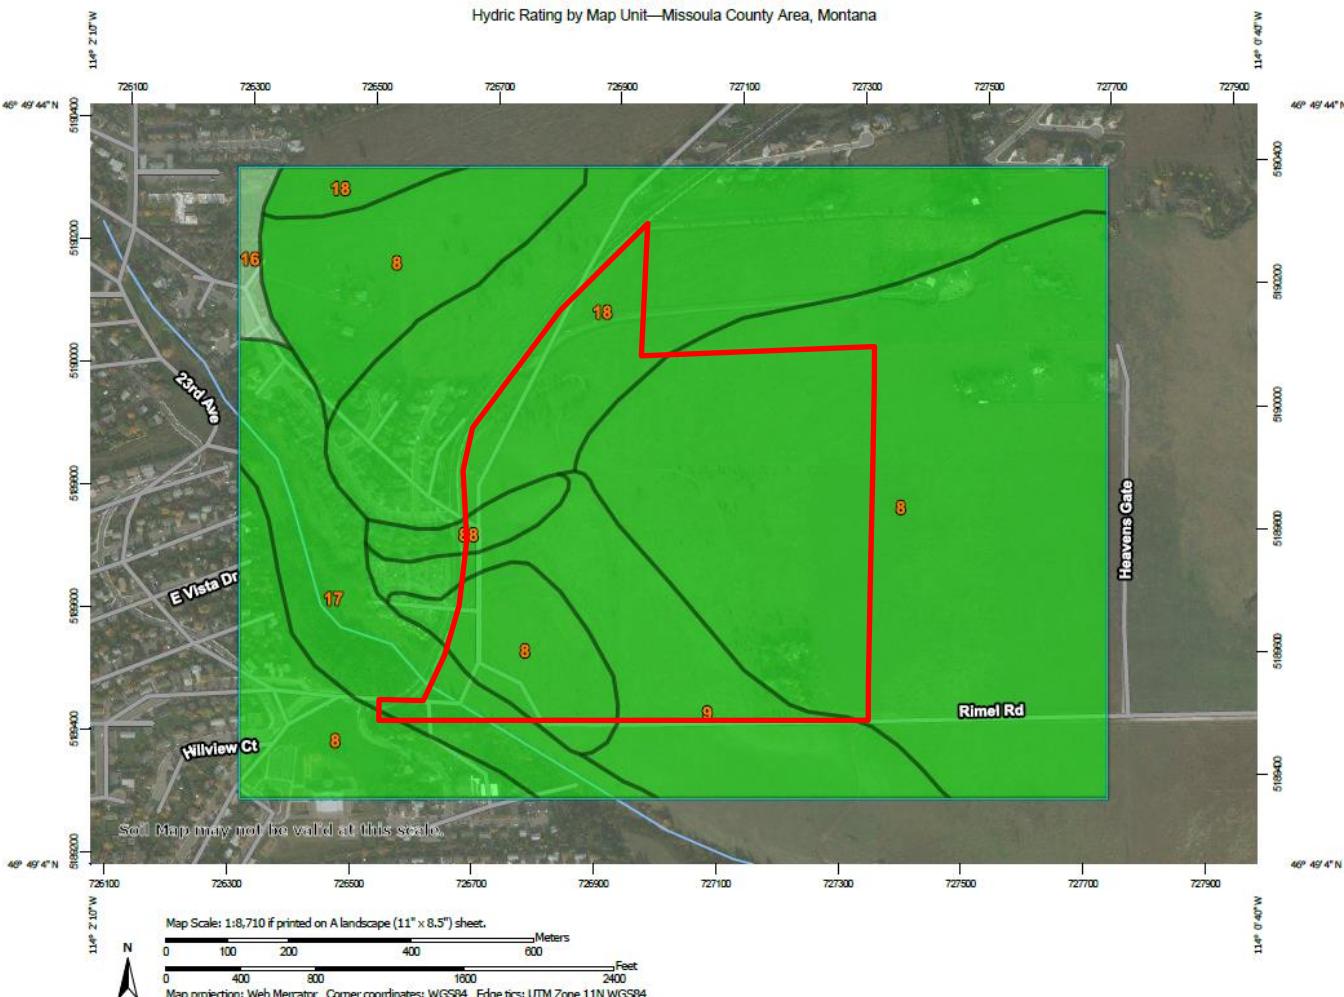
Hydric Rating by Map Unit—Missoula County Area, Montana

NRCS Soil Map (2021); red polygon is approximate site boundary.

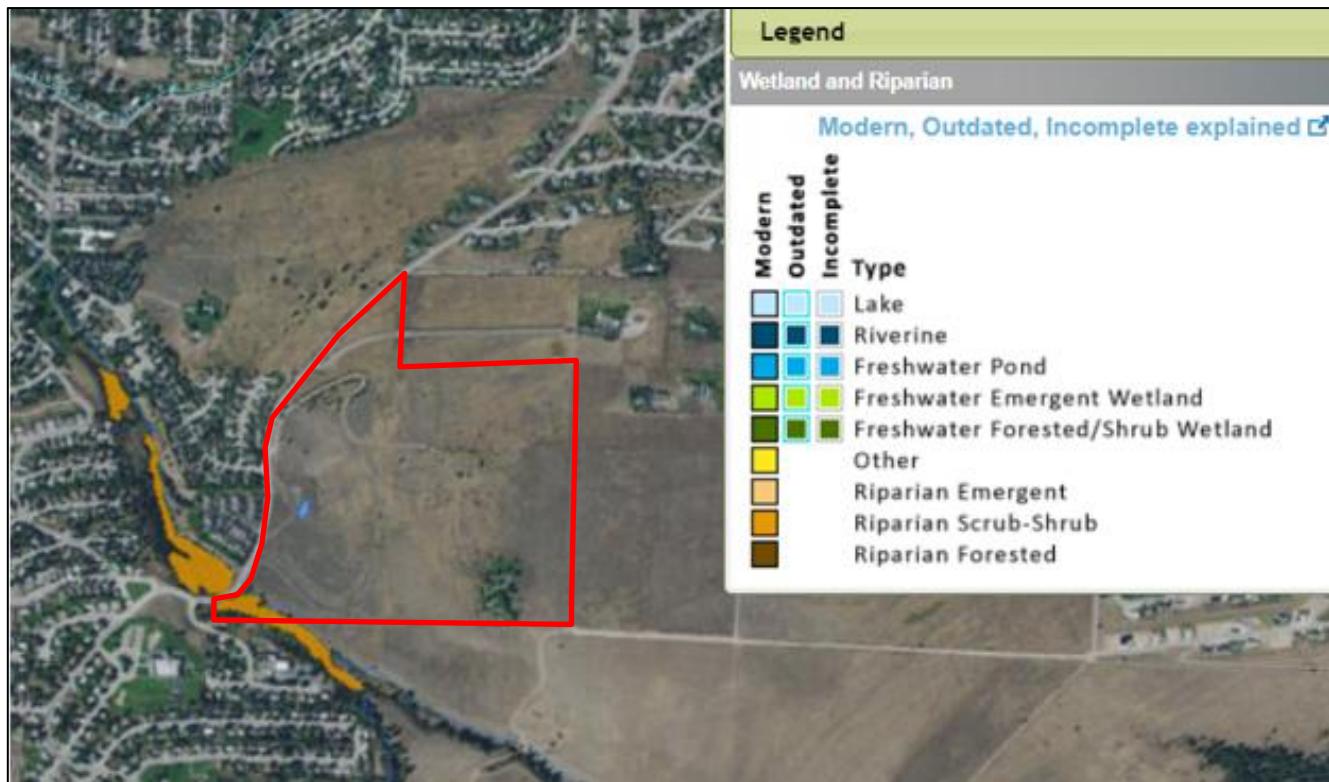
Montana Natural Heritage Program Wetland Inventory Map (MNHP 2021), red polygon illustrates approximate site boundary.

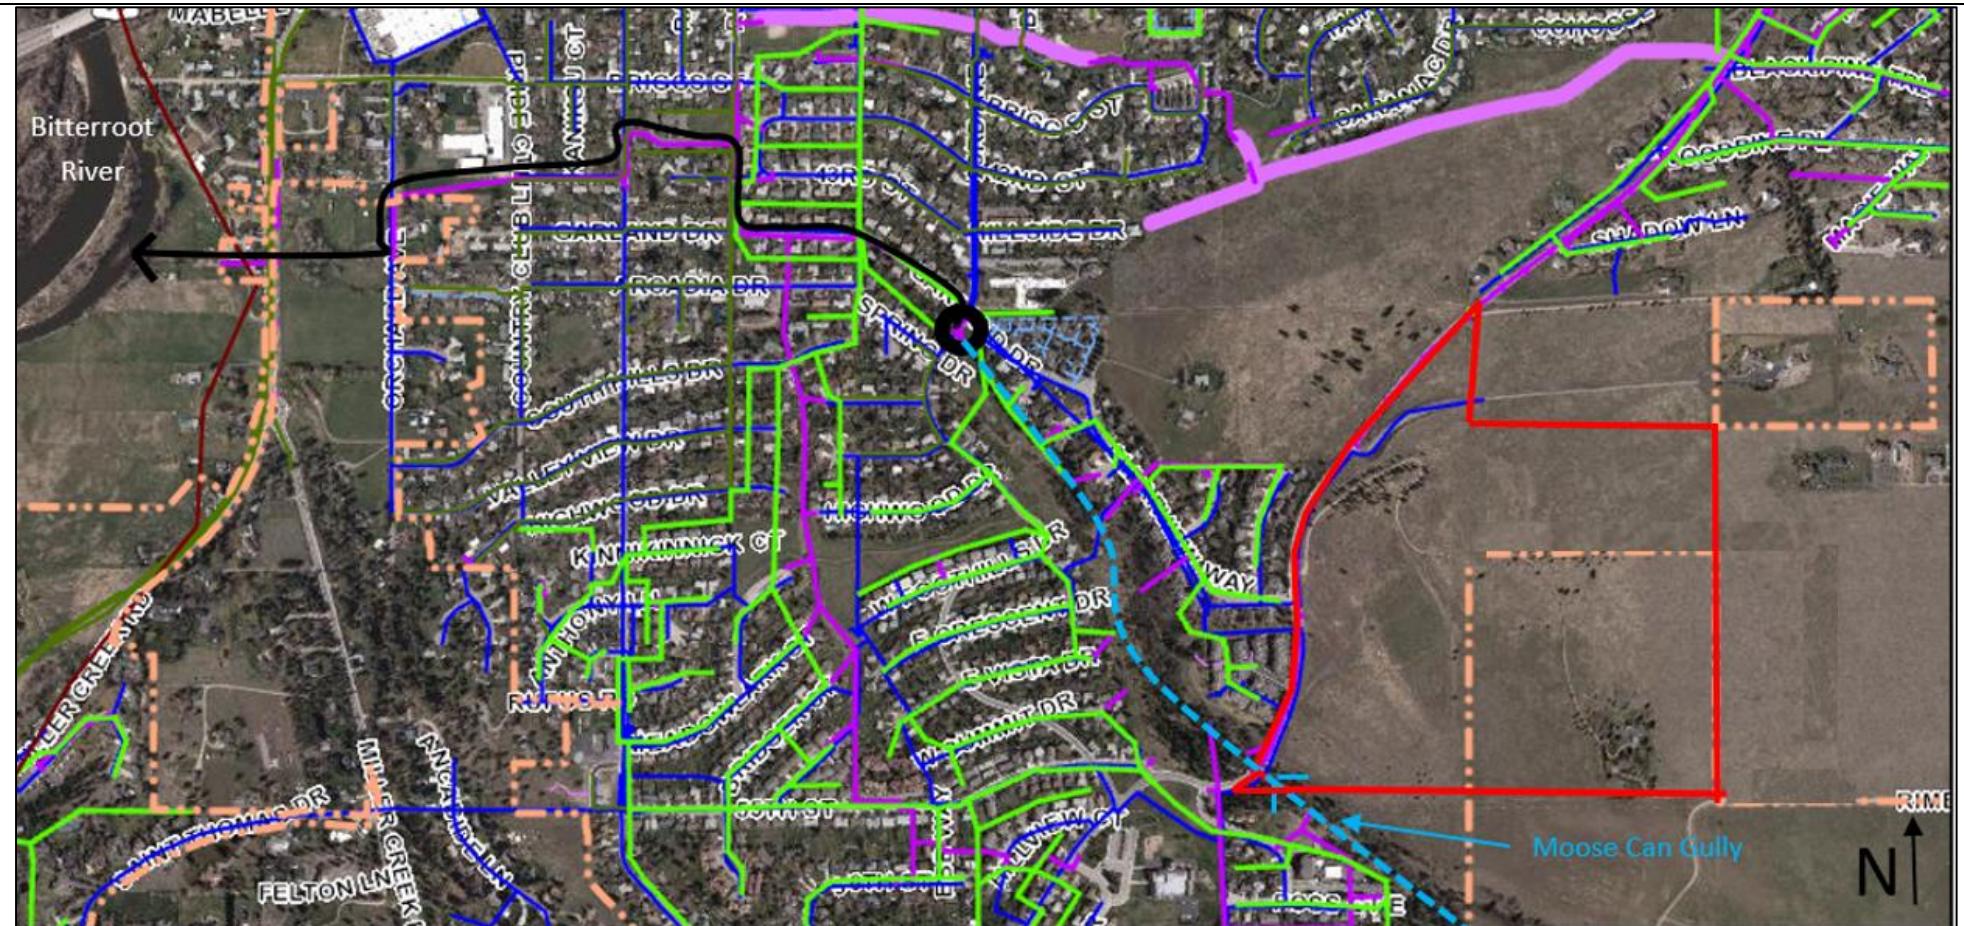
Stormwater connection of Moose Can Gully to the Bitterroot River (City of Missoula 2022): black line overlays City of Missoula pink line that indicates stormwater path and inflow on east bank of Bitterroot River; black circle indicates where Moose Can Gully runoff enters city stormwater system; blue dashed line is flow direction of perennial stream within Moose Can Gully; and, red polygon is approximate proposed Hillview Subdivision boundary.

Water conveyed downslope within Moose Can Gully enters the City of Missoula stormwater conveyance system in the vicinity of the southeast intersection corner of 23rd Avenue and Garland Drive (City of Missoula 2022; **Appendix E**). The stormwater system outfalls on the east bank of the Bitterroot River. Therefore, Moose Can Gully, its channelbed and wetland fringe are likely under federal USACE jurisdiction. At this time, development of the Hillview Subdivision proposes no impact to likely federally-regulated aquatic features within Moose Can Gully. However, if impacts are proposed in the future a Section 404 Permit would likely be required. The USACE makes the final jurisdictional determination at the time of permitting. Other environmental permits (e.g., MT310) or certification (MTDEQ 401) may also be required. In general, perennial streams do require a MT310 Permit, however the Missoula County Conservation District should be consulted to determine whether any future proposed impacts would require this authorization.
