Chapter 9

Rattlesnake Dams

Feasibility Study

2018 Water System Master Plan
Missoula, Montana

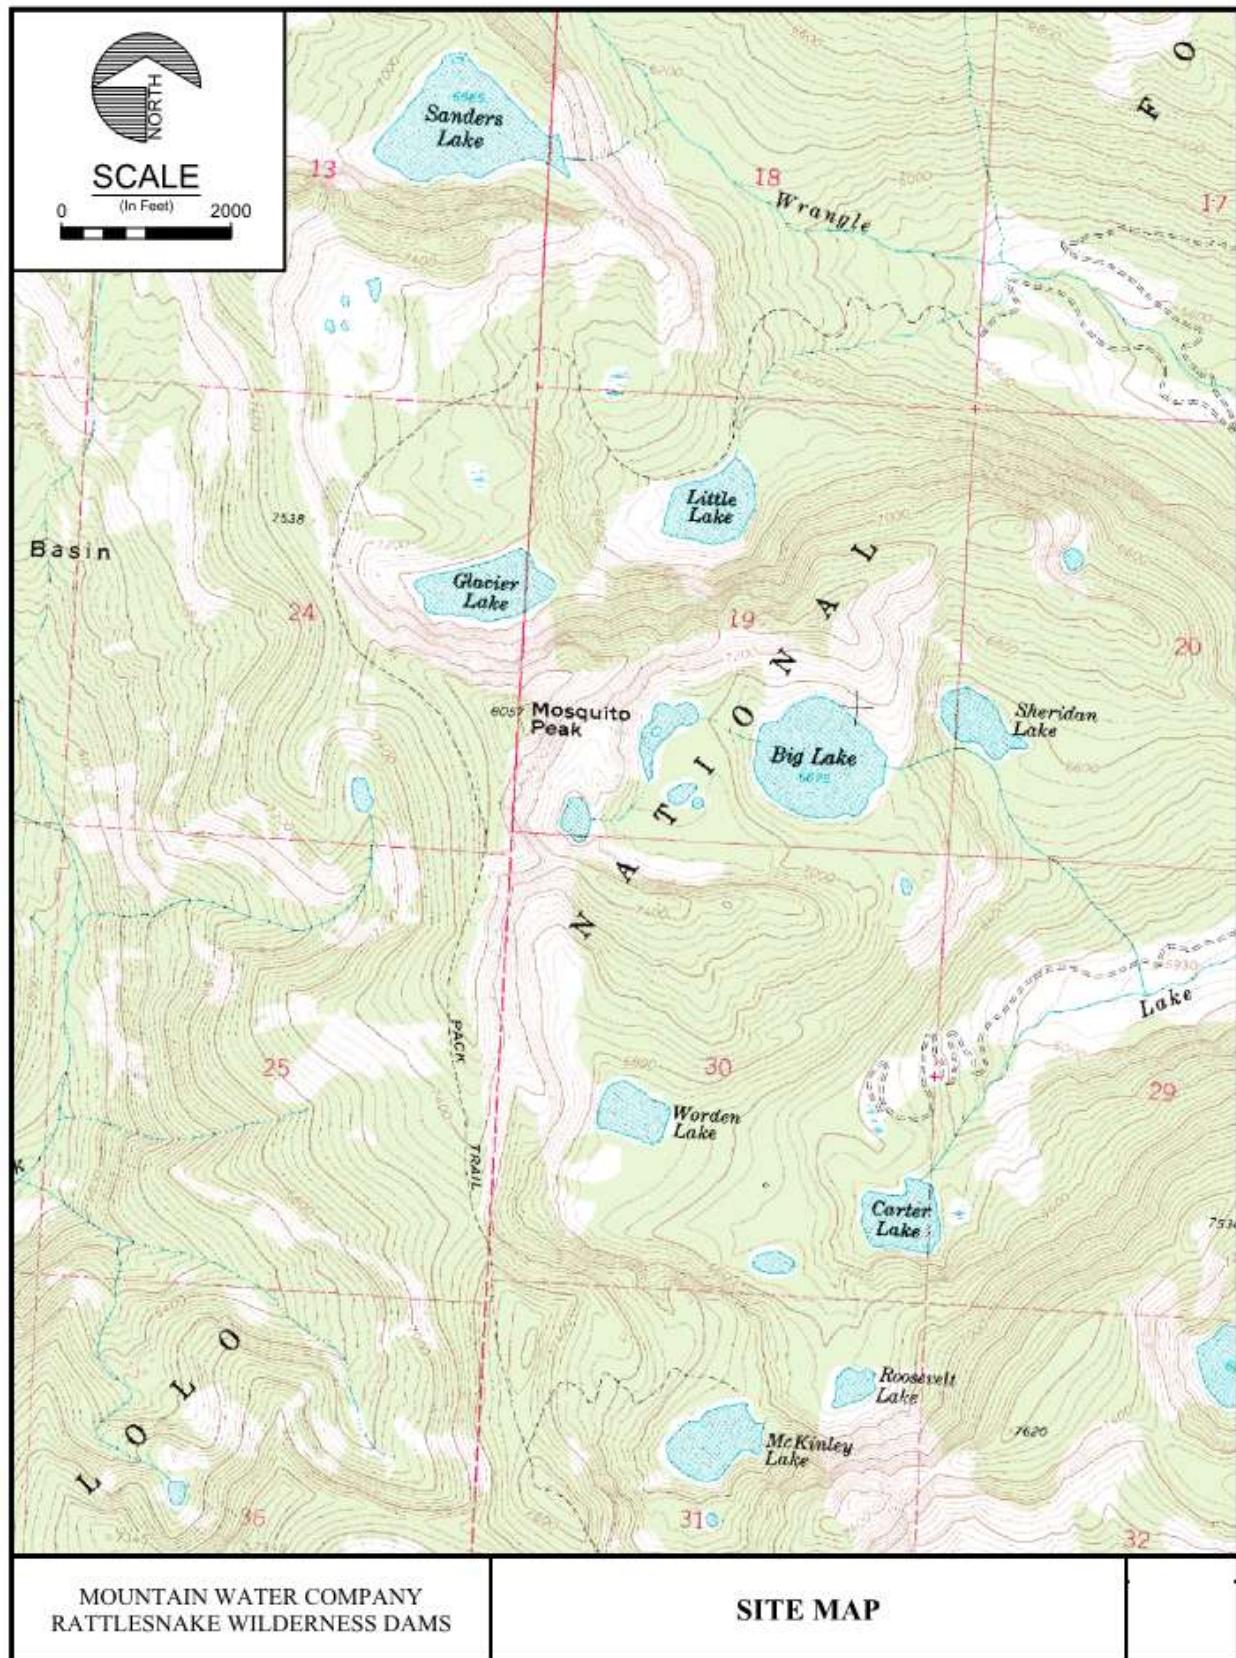
Figure 9-1. Site Map, Rattlesnake Wilderness Dams

Between 1911 and 1923, 10 dams were built on eight high mountain lakes in the present-day Rattlesnake Wilderness Area to augment water supply for the City of Missoula, see Figure 9-1. The City of Missoula acquired the dams and associated water rights from Mountain Water Company in 2017. The City of Missoula is now the owner and caretaker of these assets for the community. The purpose of this feasibility study is to determine the range of available options for the dams moving forward, and evaluate those options in terms of the relevant criteria including capital costs, life cycle costs, water rights, climate change, long-term community needs, regulatory agency requirements and goals, and environmental impacts among other benefits.

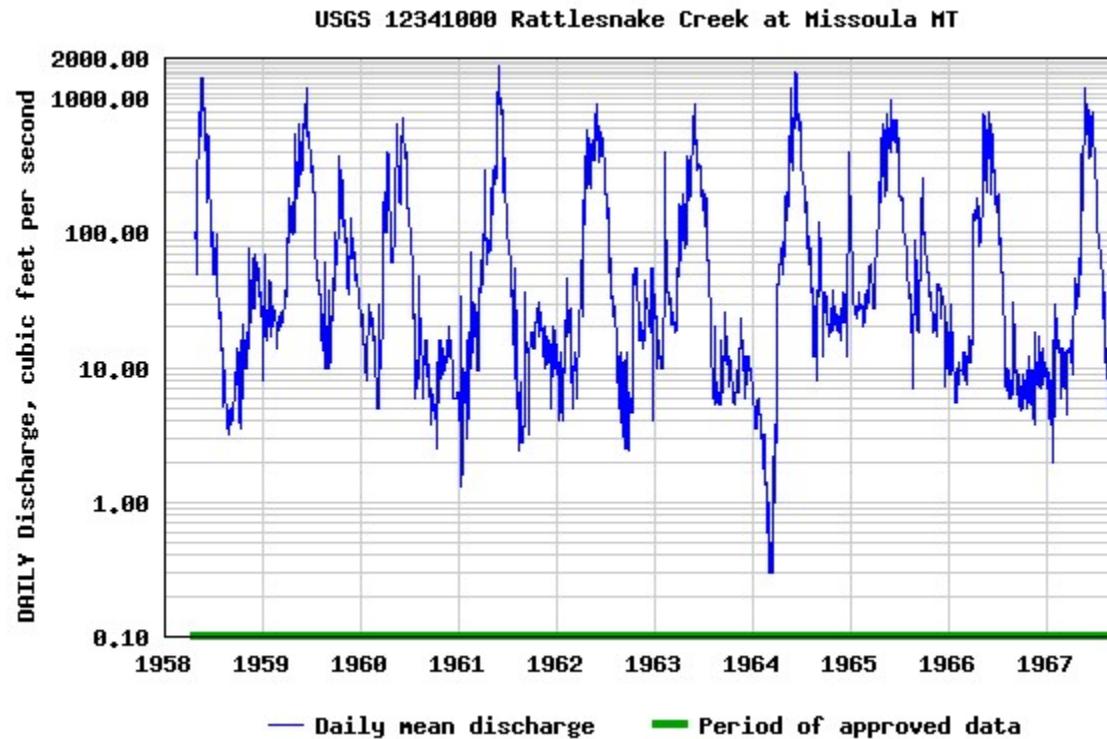
Figure 9-3. Historic Rattlesnake Creek Flow

The USGS gathered streamflow data on Rattlesnake Creek as far back as 1899, then consistently from 1957 through 1968. This data is shown in Figure 9-3. A new gage was installed and started reporting streamflow data in the fall of 2017, and this data is shown in Figure 9-4.

The minimum stream flow measured by the USGS gage was less than 1 cfs, and 8 cfs by the newly installed stream gage.

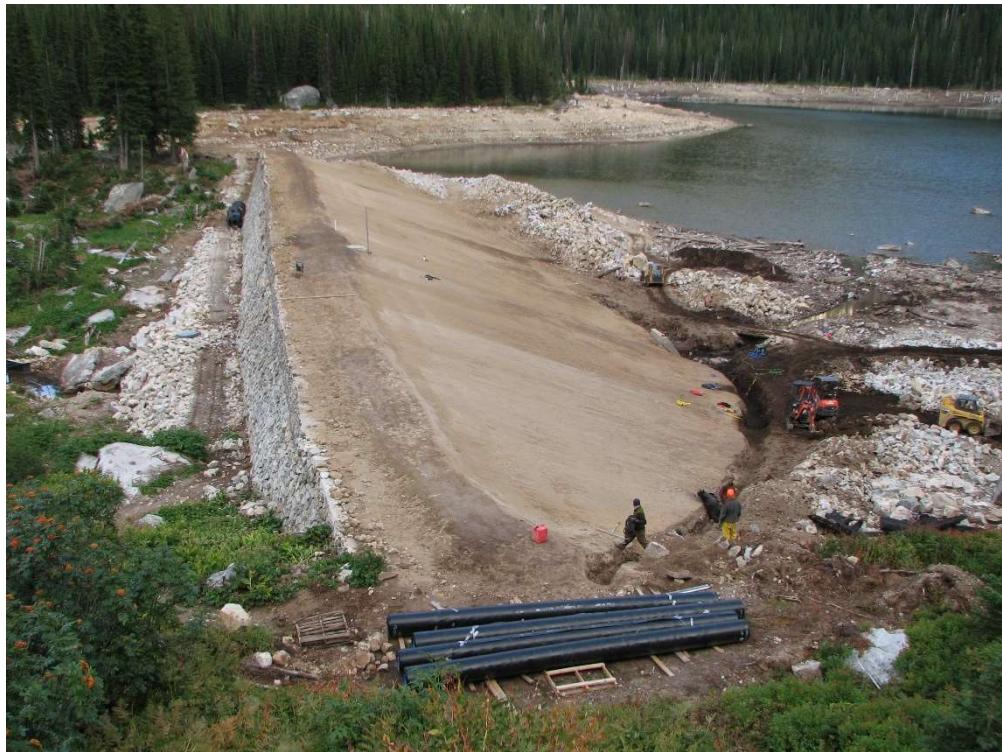
Figure 9-5. Mill Lake Dam, Geomembrane Liner Installation

A more reasonable solution to eliminate the piping concern is lining the upstream embankment slope with an impermeable geomembrane liner. This option would require temporarily removing the upstream riprap, preparing the liner subgrade, installing a geomembrane liner with cushion geotextile on both sides, and replacing the upstream riprap.

The photos below provide a visual example of the work necessary to install a geomembrane liner on the upstream dam face.

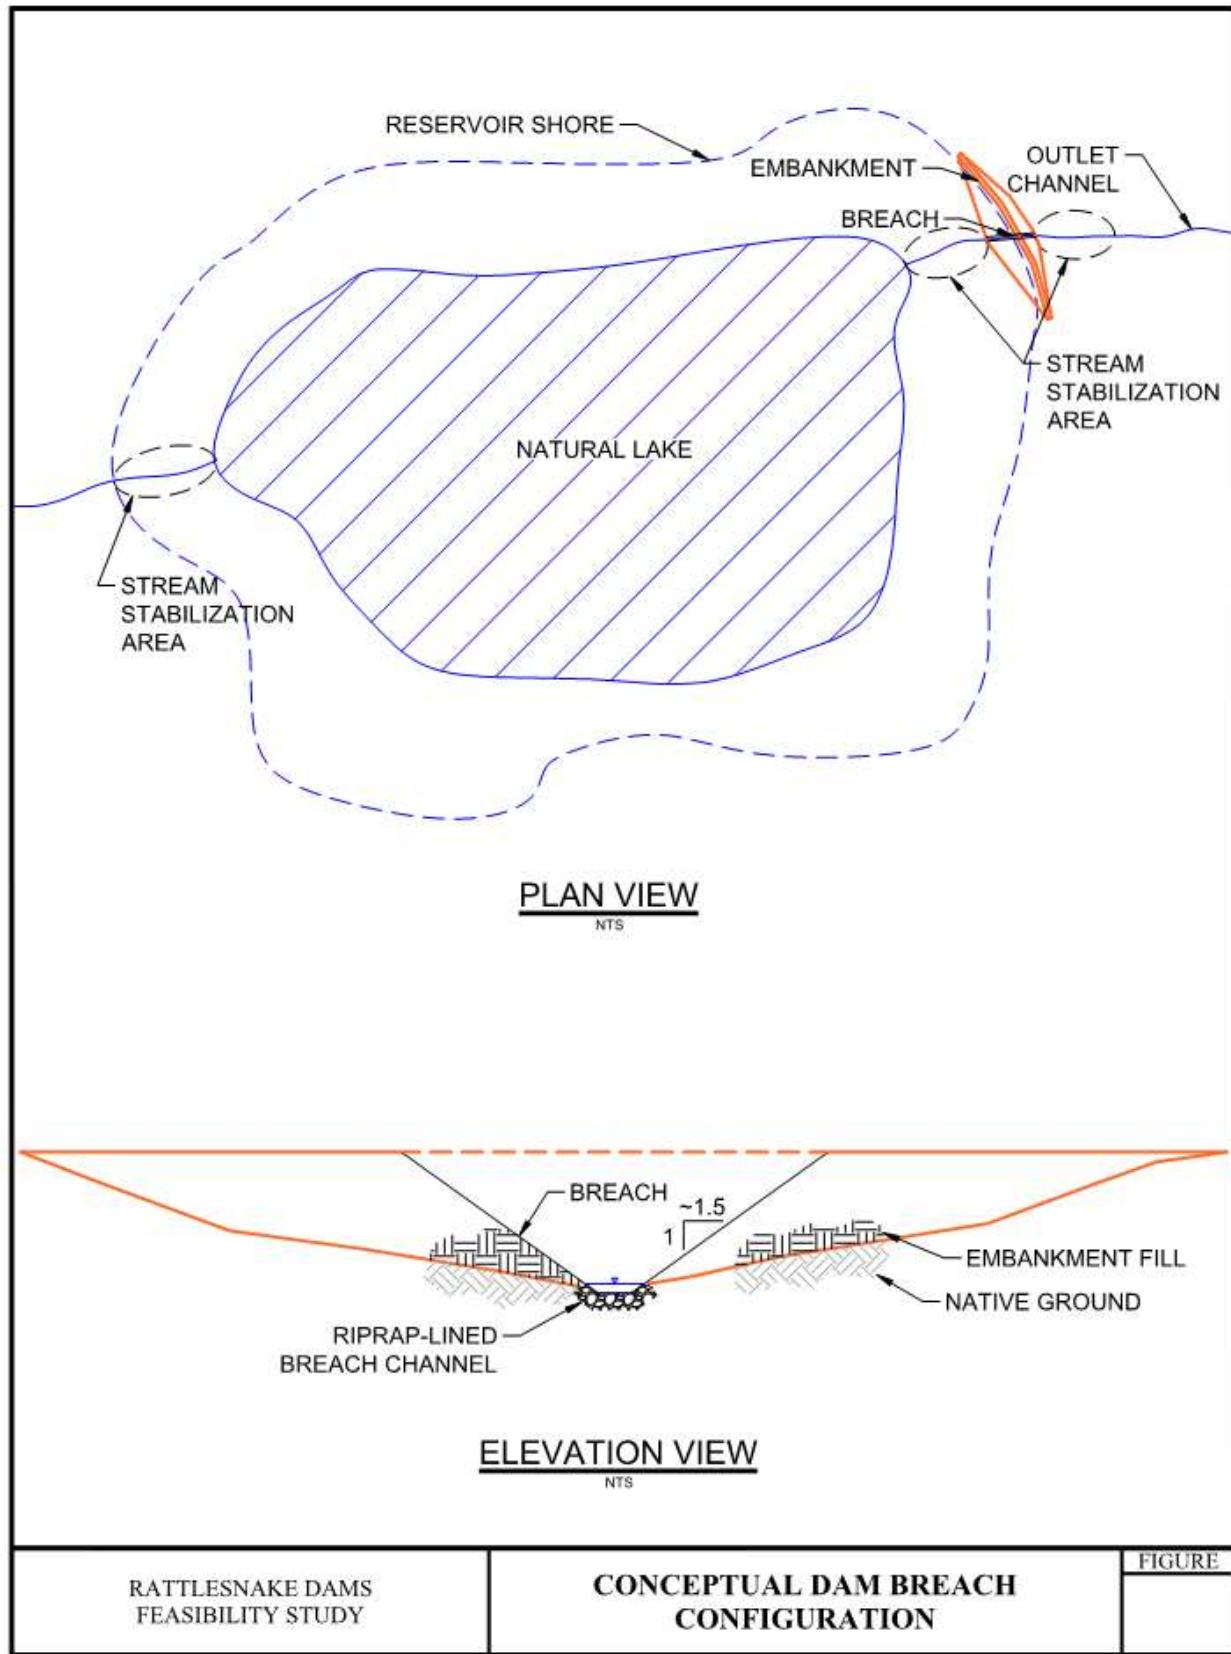
The alternative to decommission the dam would involve breaching a portion of the dam and constructing a channel to route flows past the dam to an outlet channel. Breaching the dam would eliminate its storage capacity. A stable breach channel would be excavated through the dam embankment to safely route a 100-year or larger inflow design flood and to avoid any backwater impoundment against the remaining portion of the dam. The channel could feature a control sill to reduce sediment releases until the reservoir beach stabilizes. Excavated material could be dispersed to blend within the surrounding ground in the reservoir footprint. The existing outlet gates and gate tower would be removed. The remaining beach between the current reservoir shore and the remaining natural lake would be seeded. See Figure 9-7 for a conceptual drawing of a dam decommissioning.
