**RE: Preliminary Geotechnical Evaluation
Aspire Subdivision
East of Sommers Street
Missoula, Montana
ALLWEST Project No. 723-002G**

**PRELIMINARY GEOTECHNICAL EVALUATION
ASPIRE SUBDIVISION
EAST OF SOMMERS STREET
MISSOULA, MONTANA
ALLWEST PROJECT NO. 723-002G**

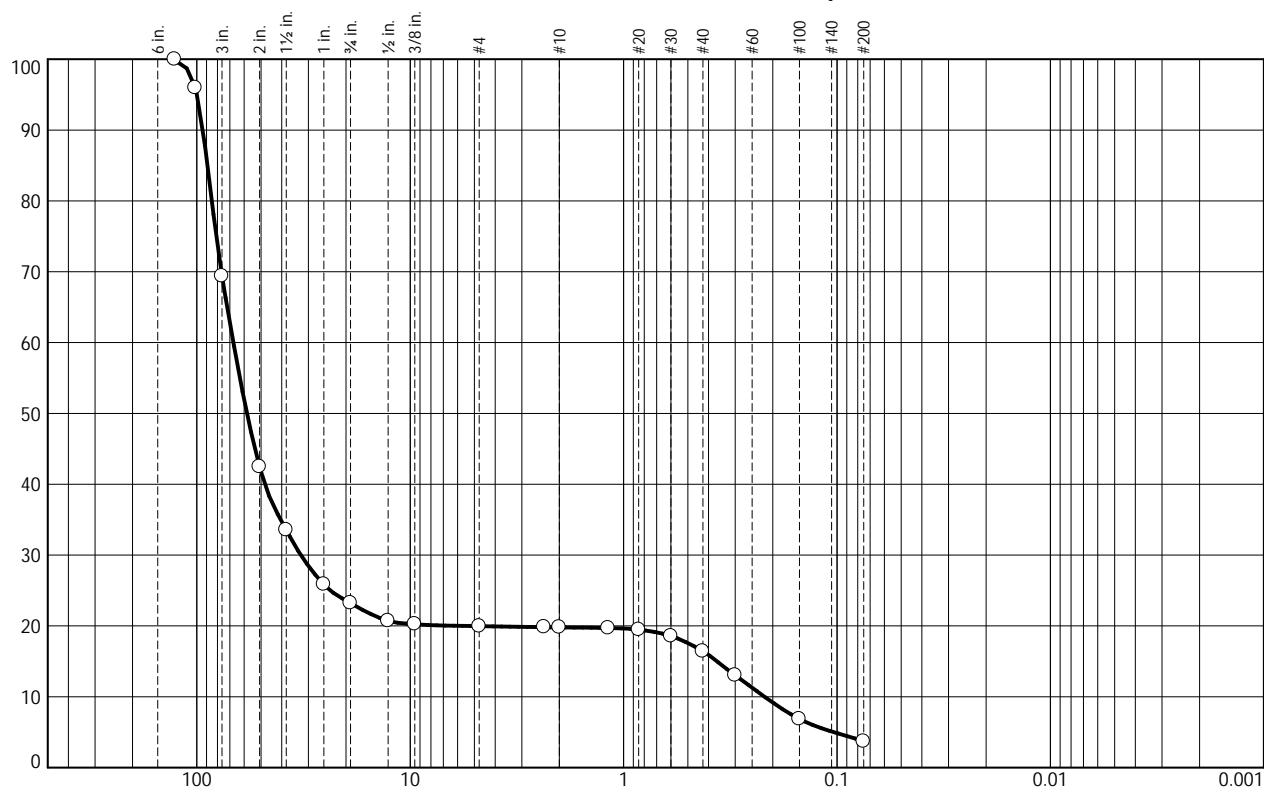
Particle Size Distribution Report

% +3"	% Gravel		% Sand			% Fines	
	Coarse	Fine	Coarse	Medium	Fine	Silt	Clay
31	46	3	0	4	12	4

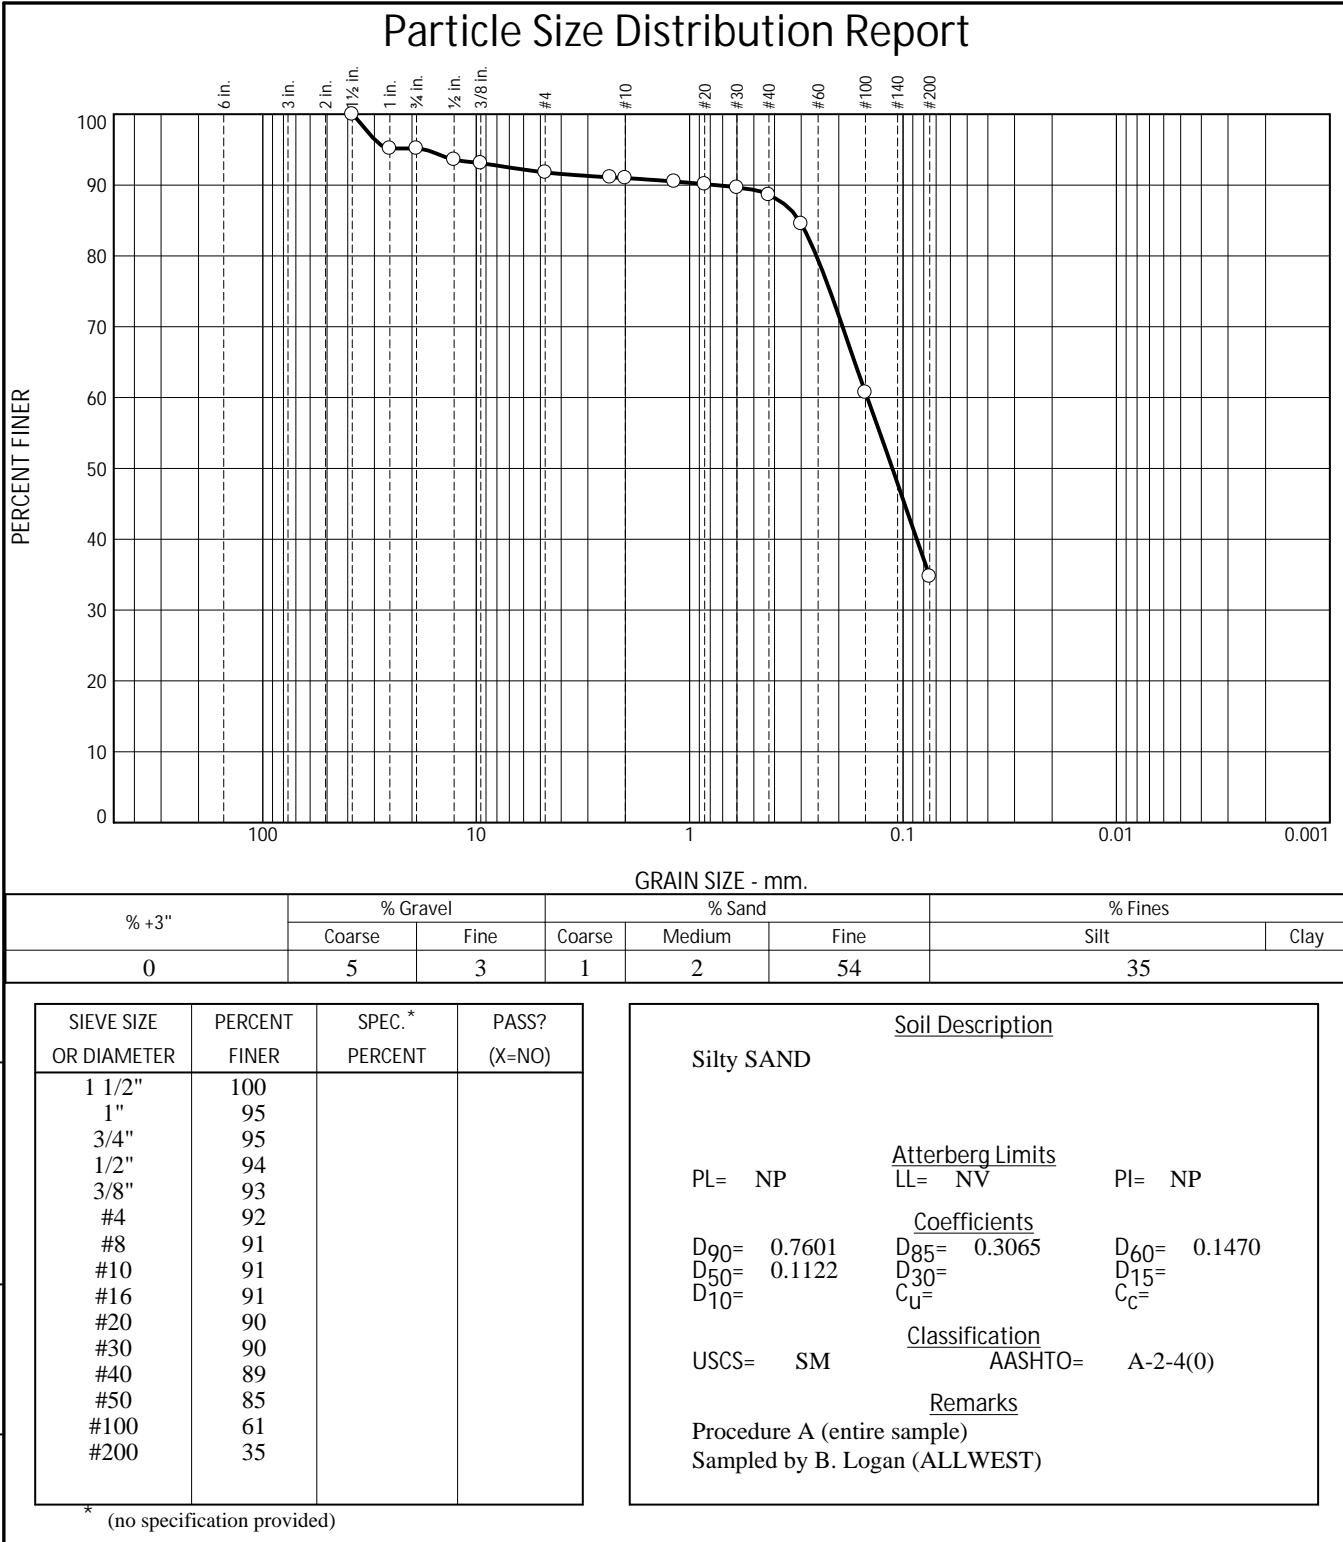
Particle Size Distribution Report

Location: Composite Sample: TP-01 (1'-4'), TP-02 (1'-4'), TP-05 (1'-2'), TP-07 (1'-6')
Sample Number: S723-0021 Depth: Varying

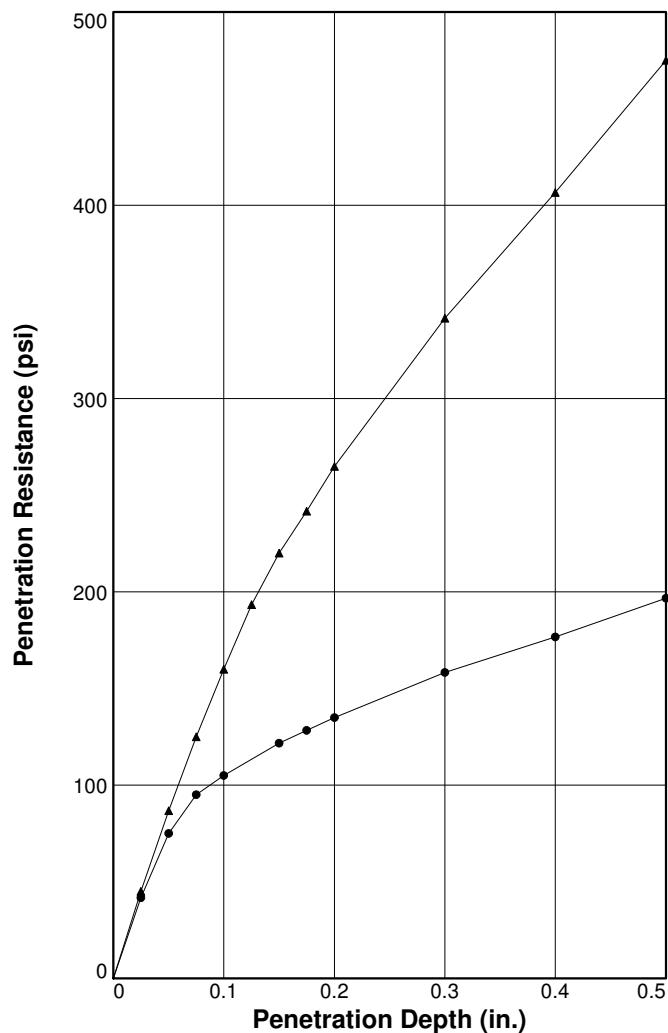
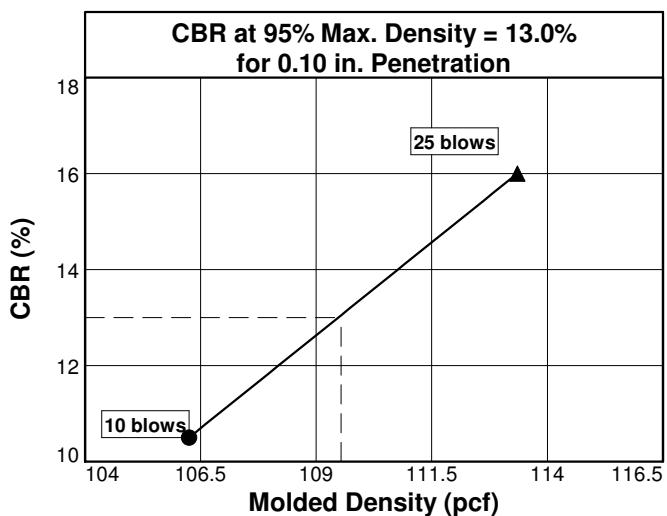
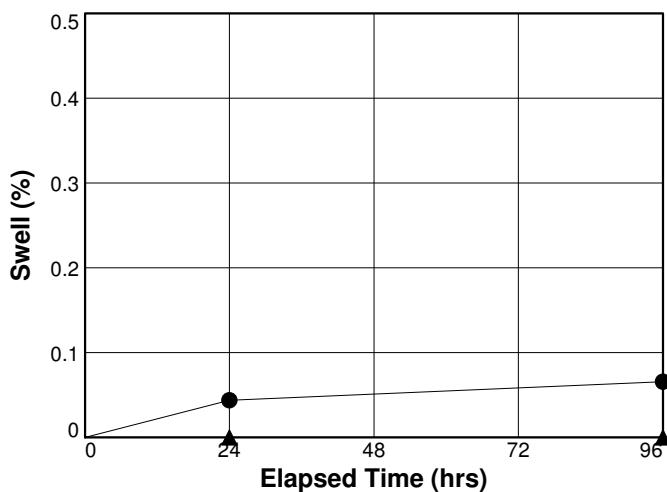
BEARING RATIO TEST REPORT

Molded			Soaked			CBR (%)		Linearity Correction (in.)	Surcharge (lbs.)	Max. Swell (%)	
	Density (pcf)	Percent of Max. Dens.	Moisture (%)	Density (pcf)	Percent of Max. Dens.	Moisture (%)	0.10 in.	0.20 in.				
1 <input checked="" type="radio"/>	106.3	92.2	12.8	106.2	92.1	13.0	10.5	9.0	0.000	10	0.1	
2 <input type="triangle"/>	113.3	98.3	13.0	113.3	98.3	12.8	16.0	17.7	0.000	10	0	
3 <input type="square"/>												
Material Description								USCS	Max. Dens. (pcf)	Optimum Moisture (%)	LL	PI
Silty sand								SM	115.3	13.2	-	-

Project No: 723-002G
Project: Aspire Subdivision
Location: Composite: TP-01 (1'-4'), TP-02 (1'-4'), TP-05 (1'-2'), TP-07 (1'-6')
Sample Number: S723-0021 **Depth:** Varying
Date: 2/20/23

California Bearing Ratio (CBR) testing was performed in accordance with ASTM D1883 on a composite sample of representative material obtained from test pits TP-01 (1 to 4 feet), TP-02 (1 to 4 feet), TP-05 (1 to 2 feet), and TP-07 (1 to 6 feet). Testing determined a CBR value of 13.0 percent when compacted to 95 percent of the maximum dry density (Figure C-7, Appendix C). CBR strengths in this range are considered a medium strength subgrade for supporting pavements under controlled placement conditions.
